2016 Vedder River Gravel Excavation
-
Habitat Changes and Environmental Impacts

(Revised) January 2018

Vedder River Management Area Committee

Nova Pacific
Environmental

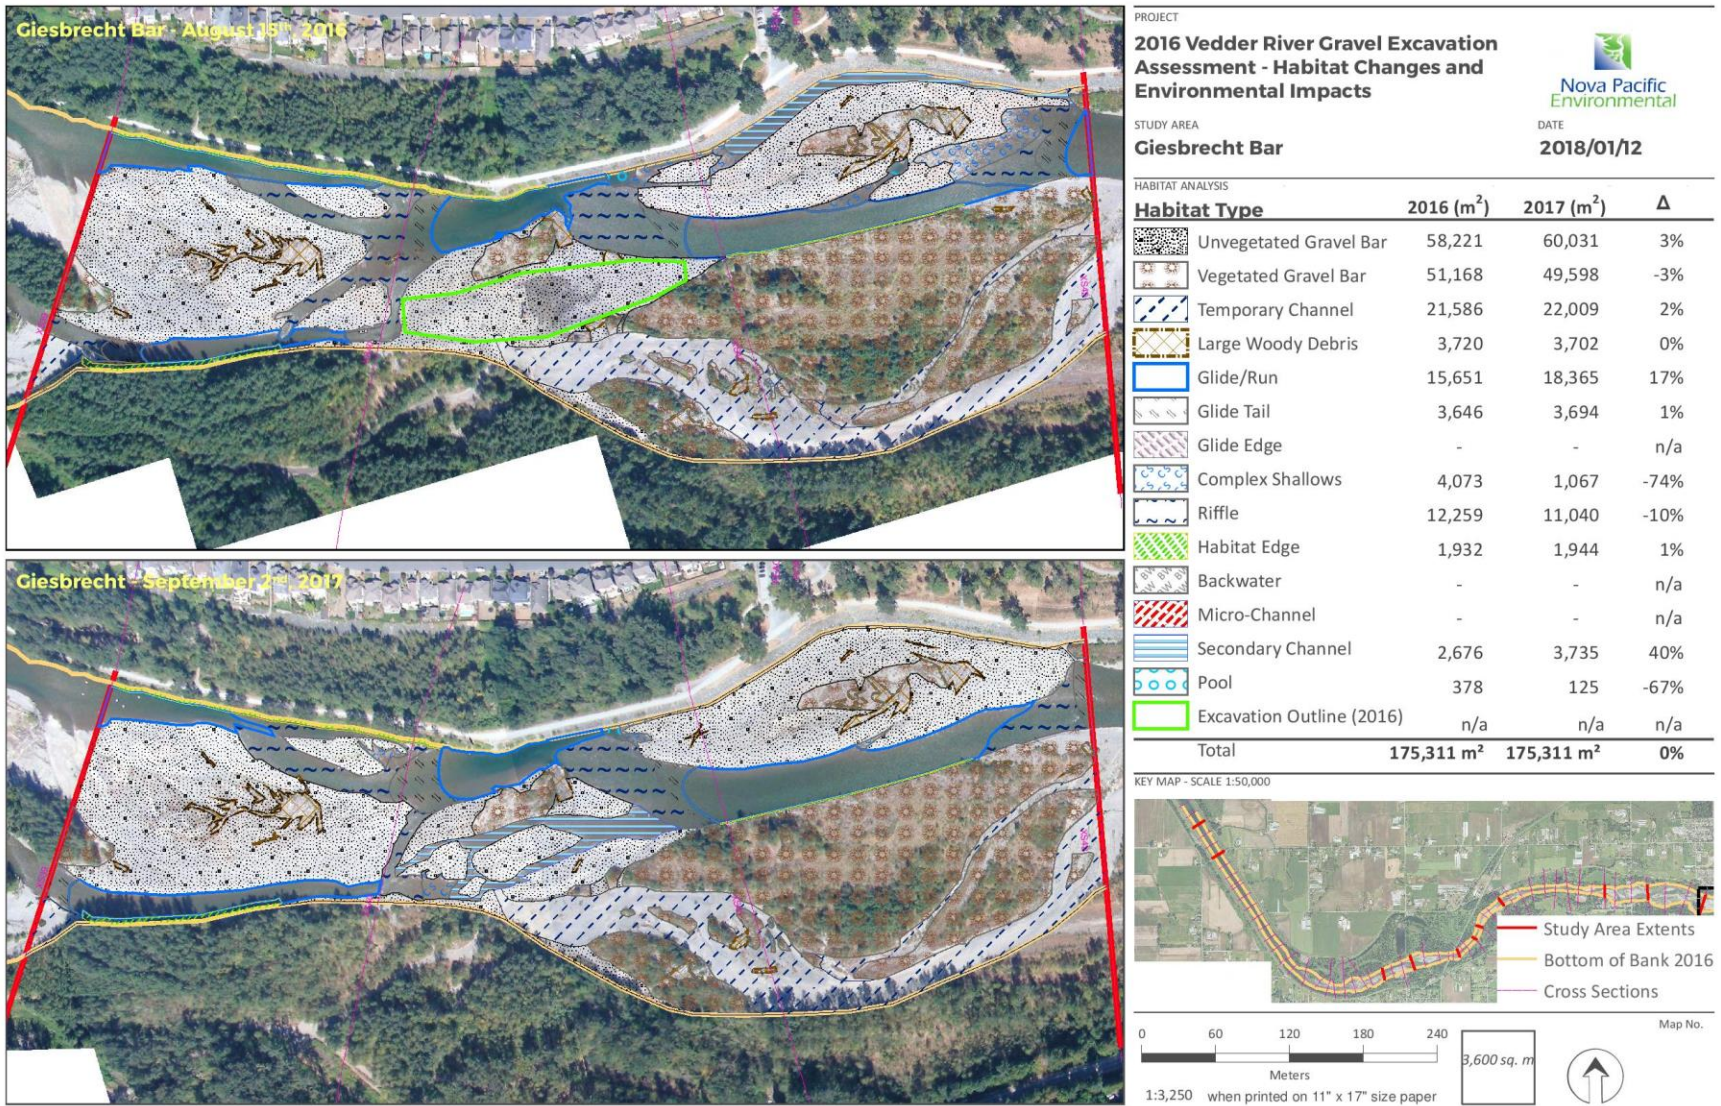
Figure 3: Habitat mapping of the Giesbrecht Bar location prior to excavation in 2016 (top) and one year later in 2017

The habitat mapping assessment showed a 2% decrease in overall habitat rating for this study area. Review of the maps and calculated habitat ratings shows an increase in unvegetated gravel bar and losses in vegetated gravel bar, complex shallows and the one small pool along the right bank. Secondary channel habitat has increased overall, with the increase within the excavation footprint offset by a decrease upstream of the excavation. The upstream habitat losses may be due in part to aggradation, however, with limitations on achieving perfectly matched flows for comparison purposes, a final determination would be dependent on pending survey data. Regardless, this change should not be seen as an effect of the excavation. It is possible the reduction in complex shallow, pool and secondary channel habitat upstream of the excavation could be attributed to the water flow being lower at the time of the aerial photo in 2017.

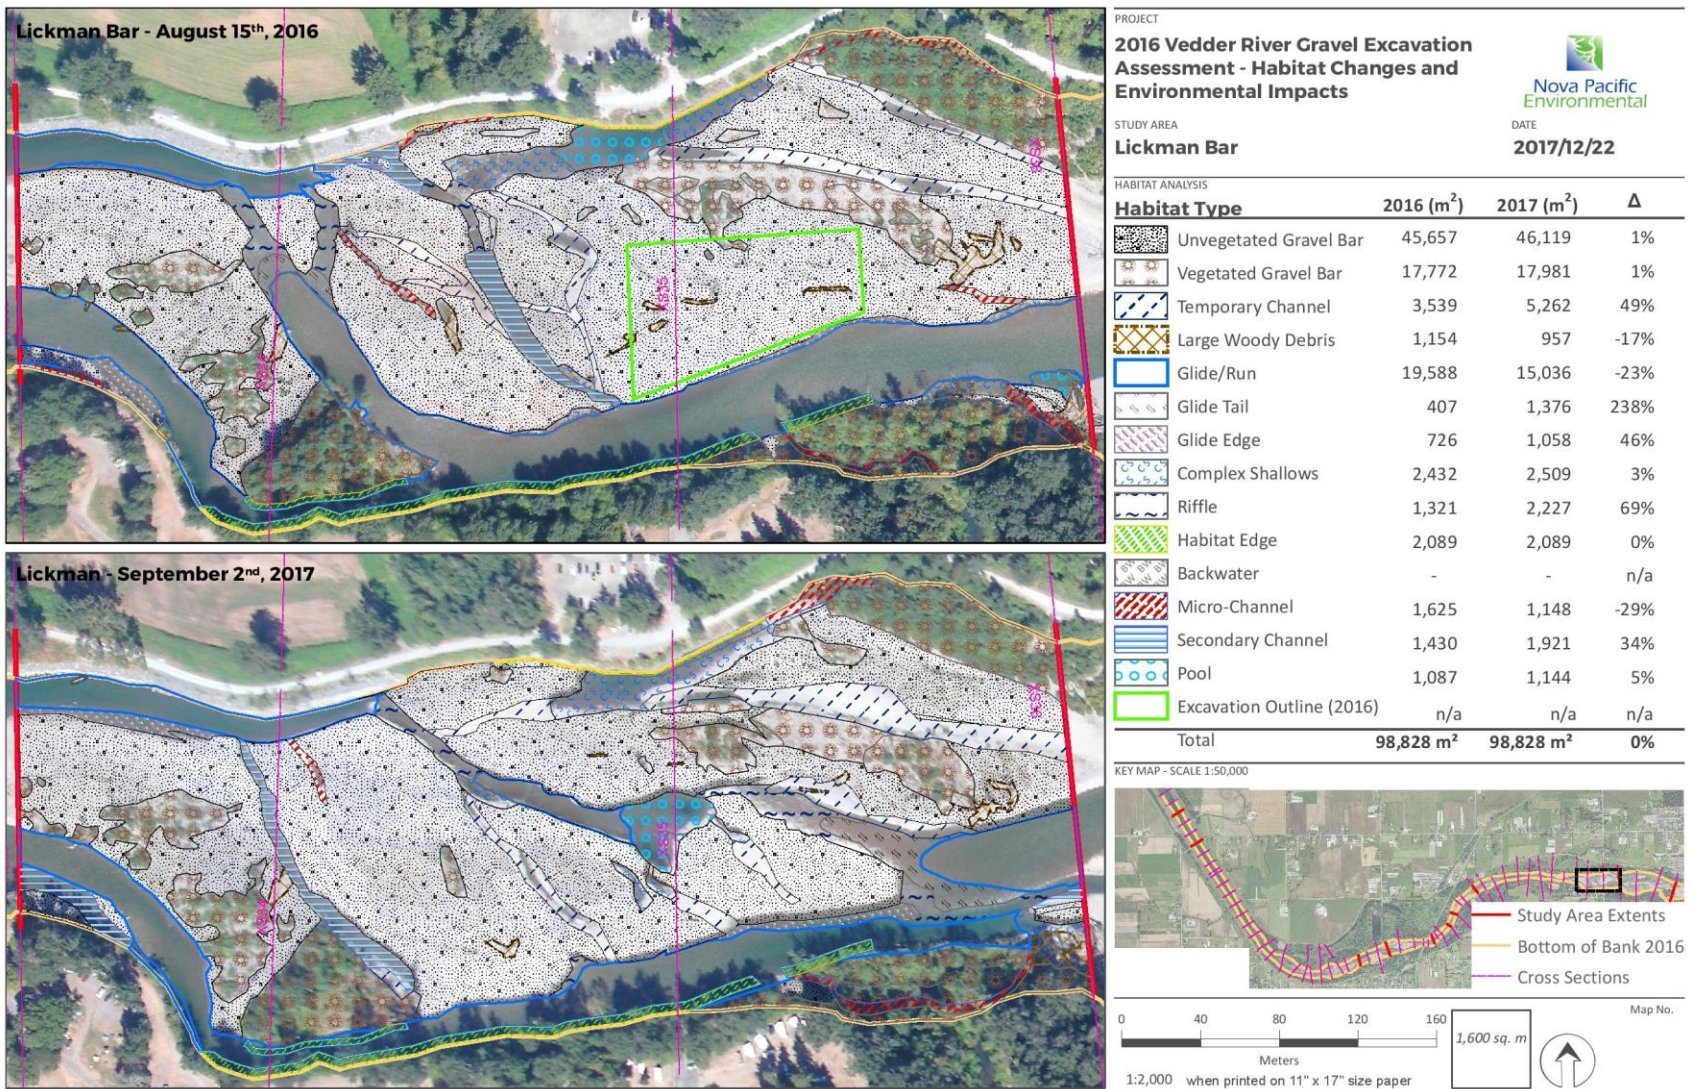
Figure 6: Habitat mapping of the Lickman Bar location prior to excavation in 2016 (top) and one year later in 2017 (bottom).

The habitat mapping assessment showed a 2% increase in overall habitat rating for this study area. Review of the maps and calculated habitat ratings shows small increases in both unvegetated and gravel bar habitats and a large decrease in glide habitat. The positive habitat rating arises from increases in secondary and temporary channels, glide tail, glide edge, riffle, pool and complex shallow habitats. Loss of some LWD was observed primarily at the upstream end of bar and in the excavation area.

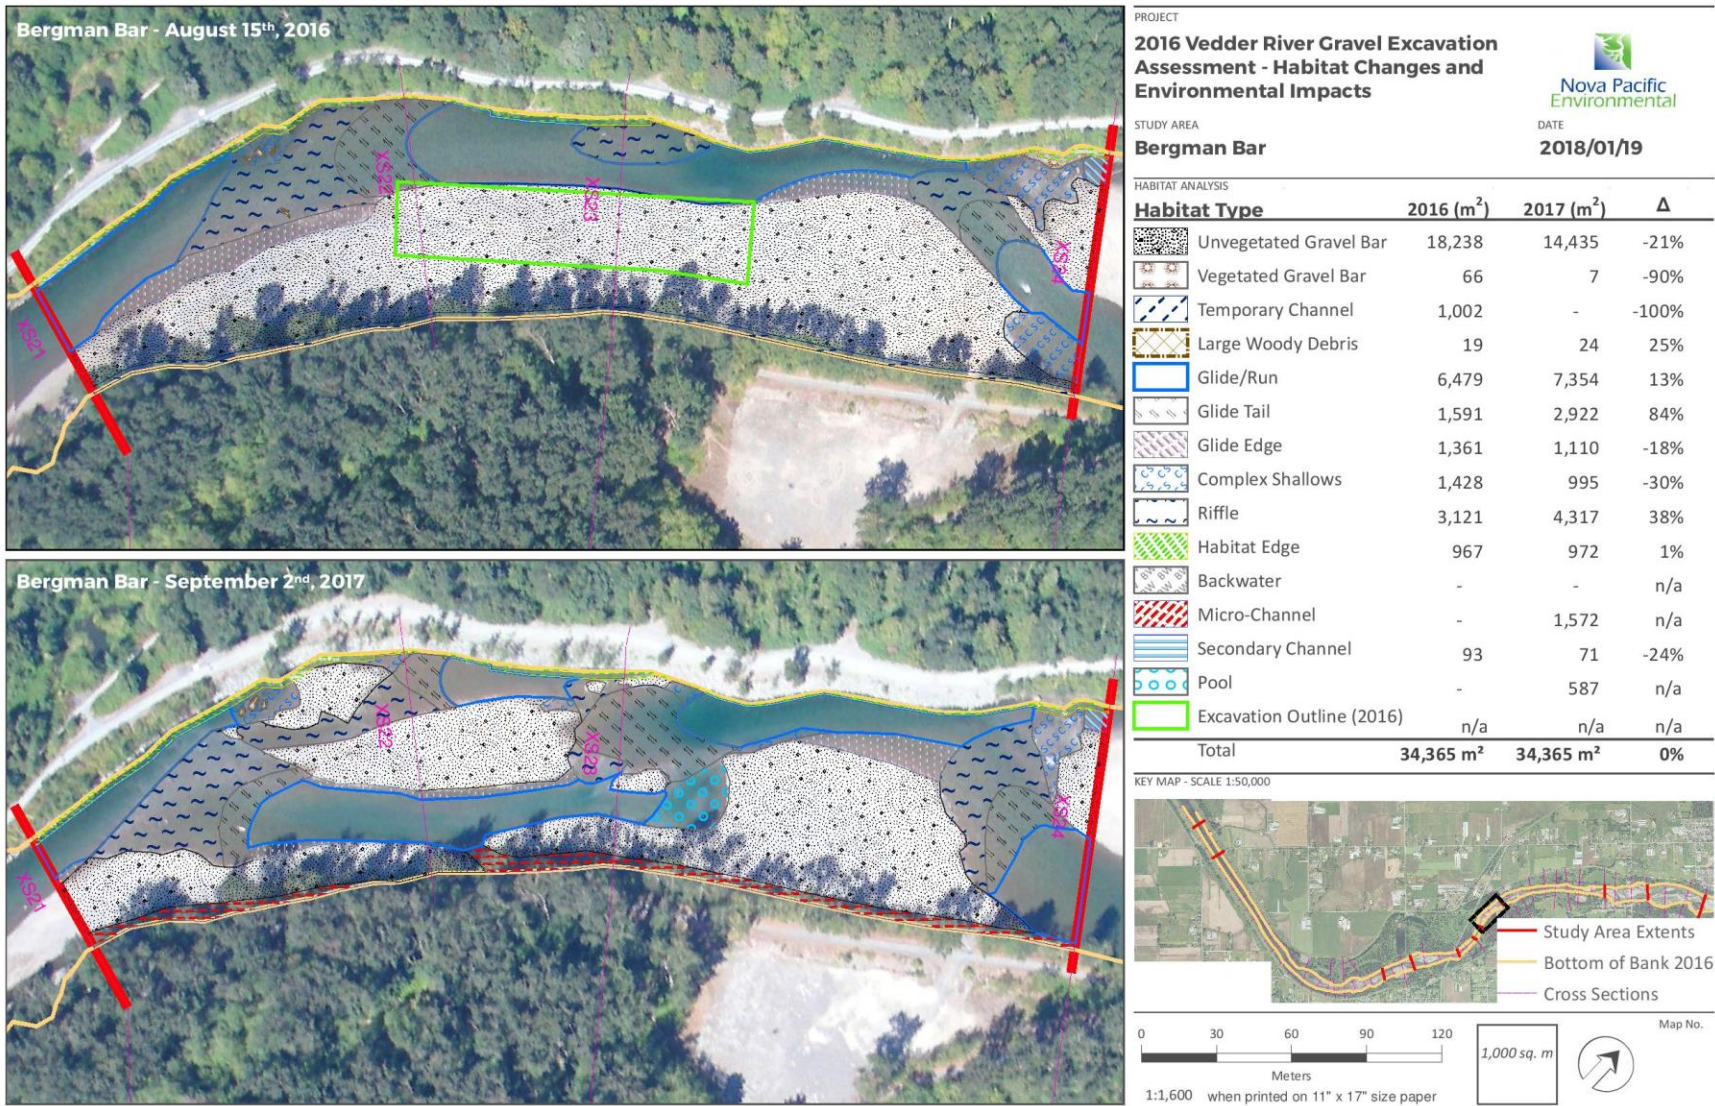
Figure 9: Habitat mapping of the Bergman Bar location prior to excavation in 2016 (top) and one year later in 2017 (bottom).

The biggest change observed at Bergman Bar is that the main channel now forks and passes through the bar in the area of the excavation replacing unvegetated gravel bar with higher rated habitat polygons and greater habitat diversity. The upstream end of the excavation has not refilled but provides high habitat value as a large eddy pool. This pool and the enhancement of the microchannel along the left bank during the excavation have improved the habitat rating in the study area. Other changes include a wider glide edge upstream of the excavation, a new glide tail/riffle sequence at XS 23 and some expansion of unvegetated gravel bar areas near the downstream end of the study area.

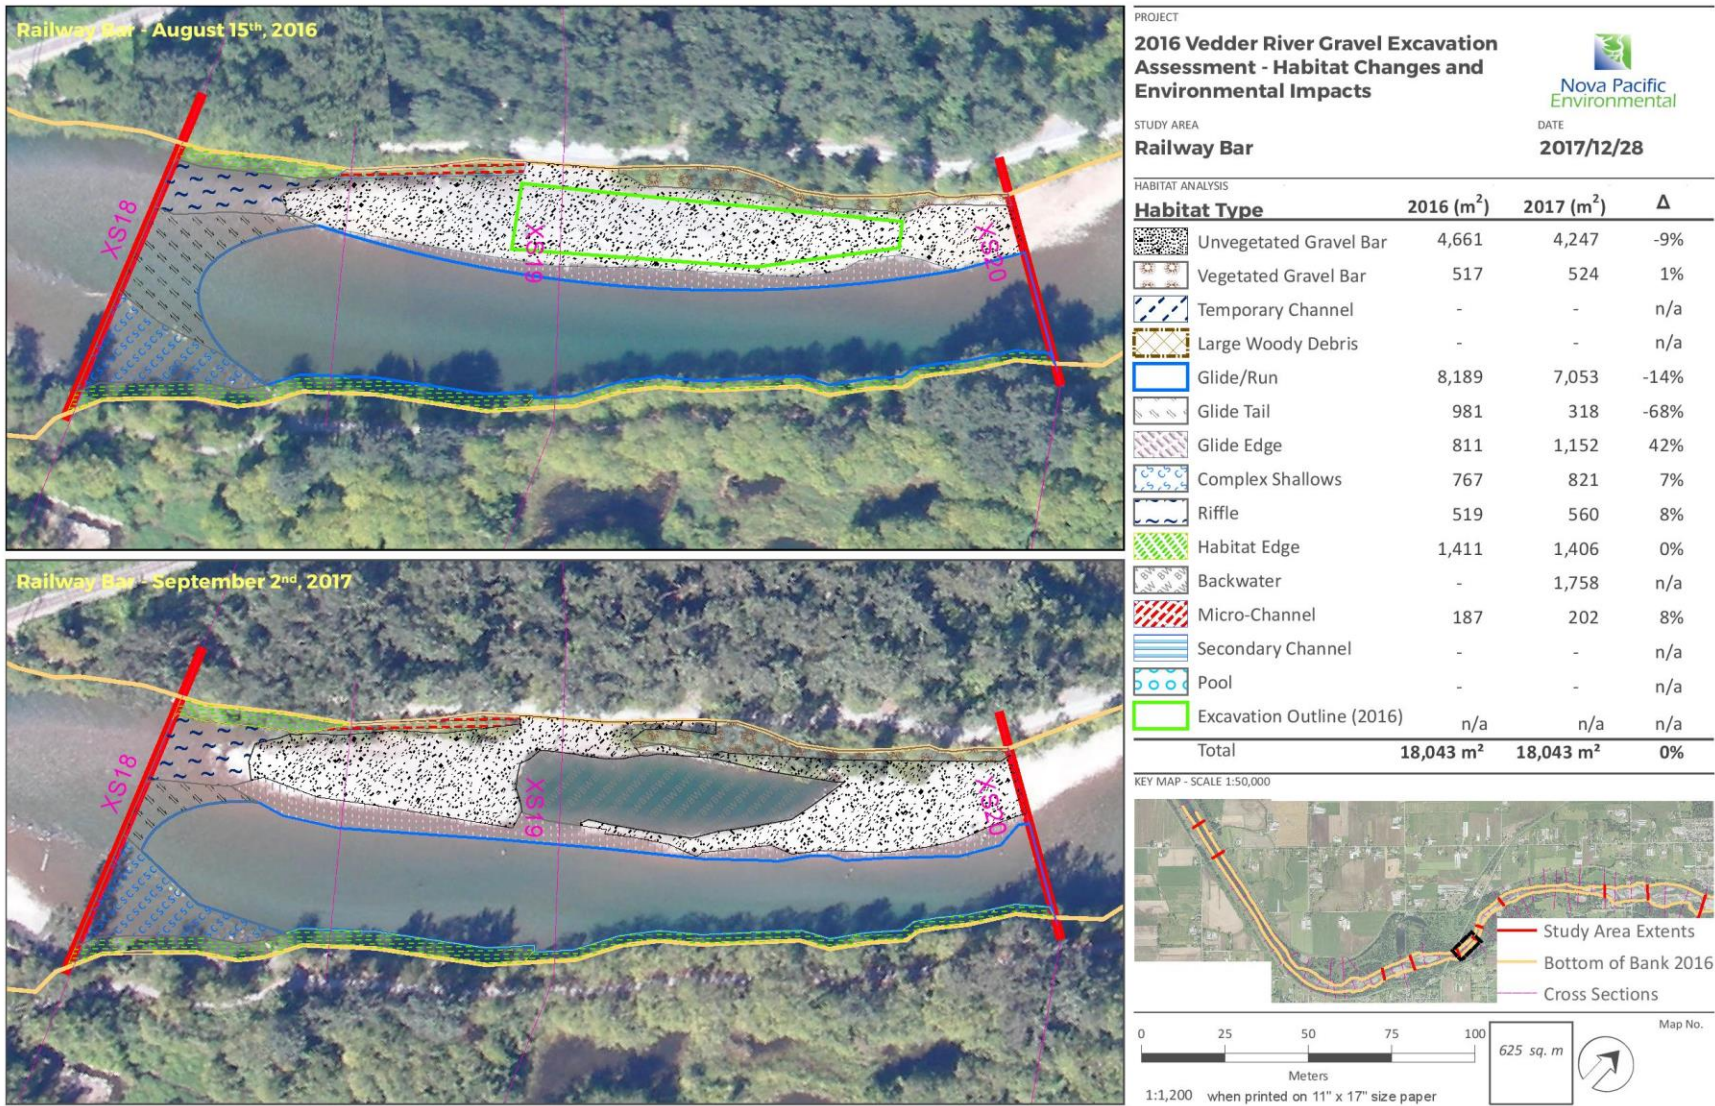
Figure 12: Habitat mapping of the Railway Bar location prior to excavation in 2016 (top) and one year later in 2017 (bottom).

The biggest change at Railway Bar was replacement of unvegetated gravel bar habitat with backwater habitat remaining within the footprint of the excavation. The glide tail downstream of the excavation appears to have migrated downstream leading to a reduction within the study area. There was also an increase in glide edge along the bar downstream of the excavation.

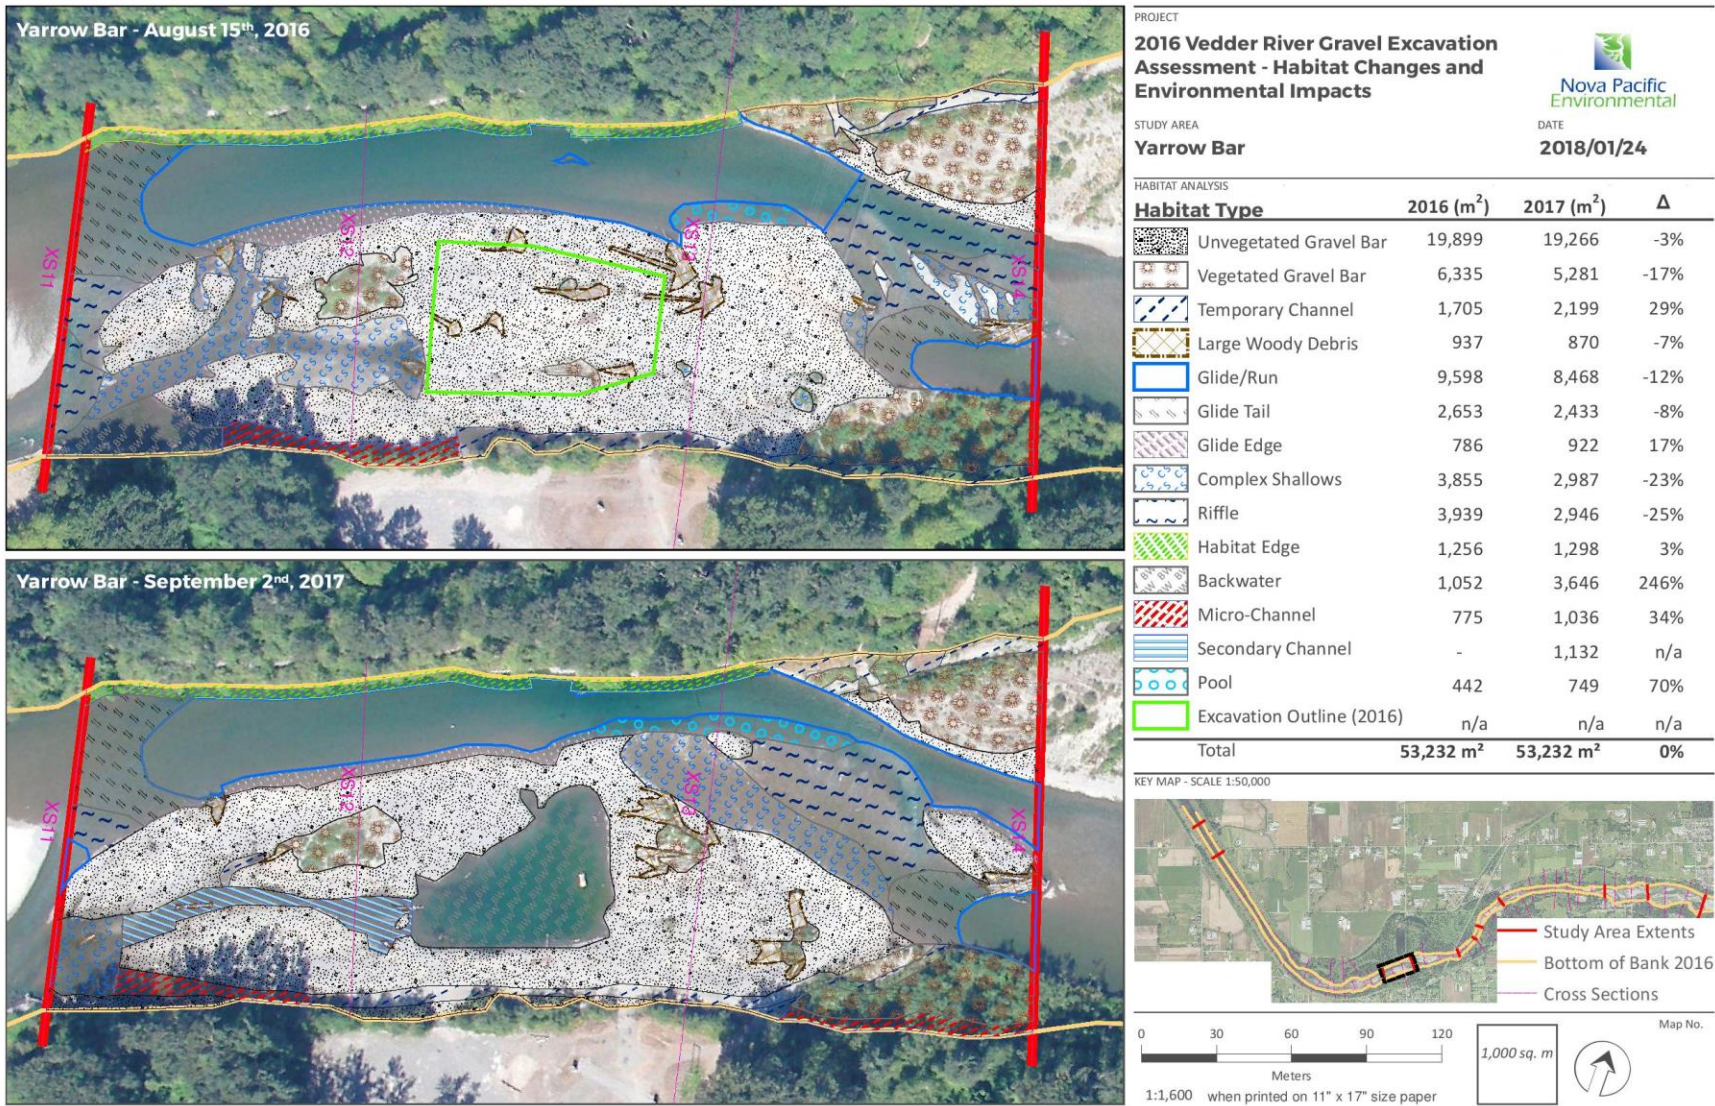
Figure 15: Habitat mapping of the Yarrow Bar location prior to excavation in 2016 (top) and one year later in 2017 (bottom).

Downstream of the excavation complex shallows, which were the remnant of the 2014 excavation, are smaller in area. As well, as a result of increased flow this complex shallow habitat has converted to secondary channel. Upstream configuration has changed with decreased riffle habitat, more complex shallows as the upstream end of the bar has appeared to be subject to deposition. It also appears the linear pool has lengthened along the head of the bar. These changes would not be a direct effect of the excavation. Finally, the remnant of the excavation provides a large area of backwater habitat.

Two recommendations for the next excavation at this site are to ensure the berm left along the main channel is as narrow as possible and the openings are as deep and wide as possible and secondly to ensure the length to width ratio is at least approaching 2:1.

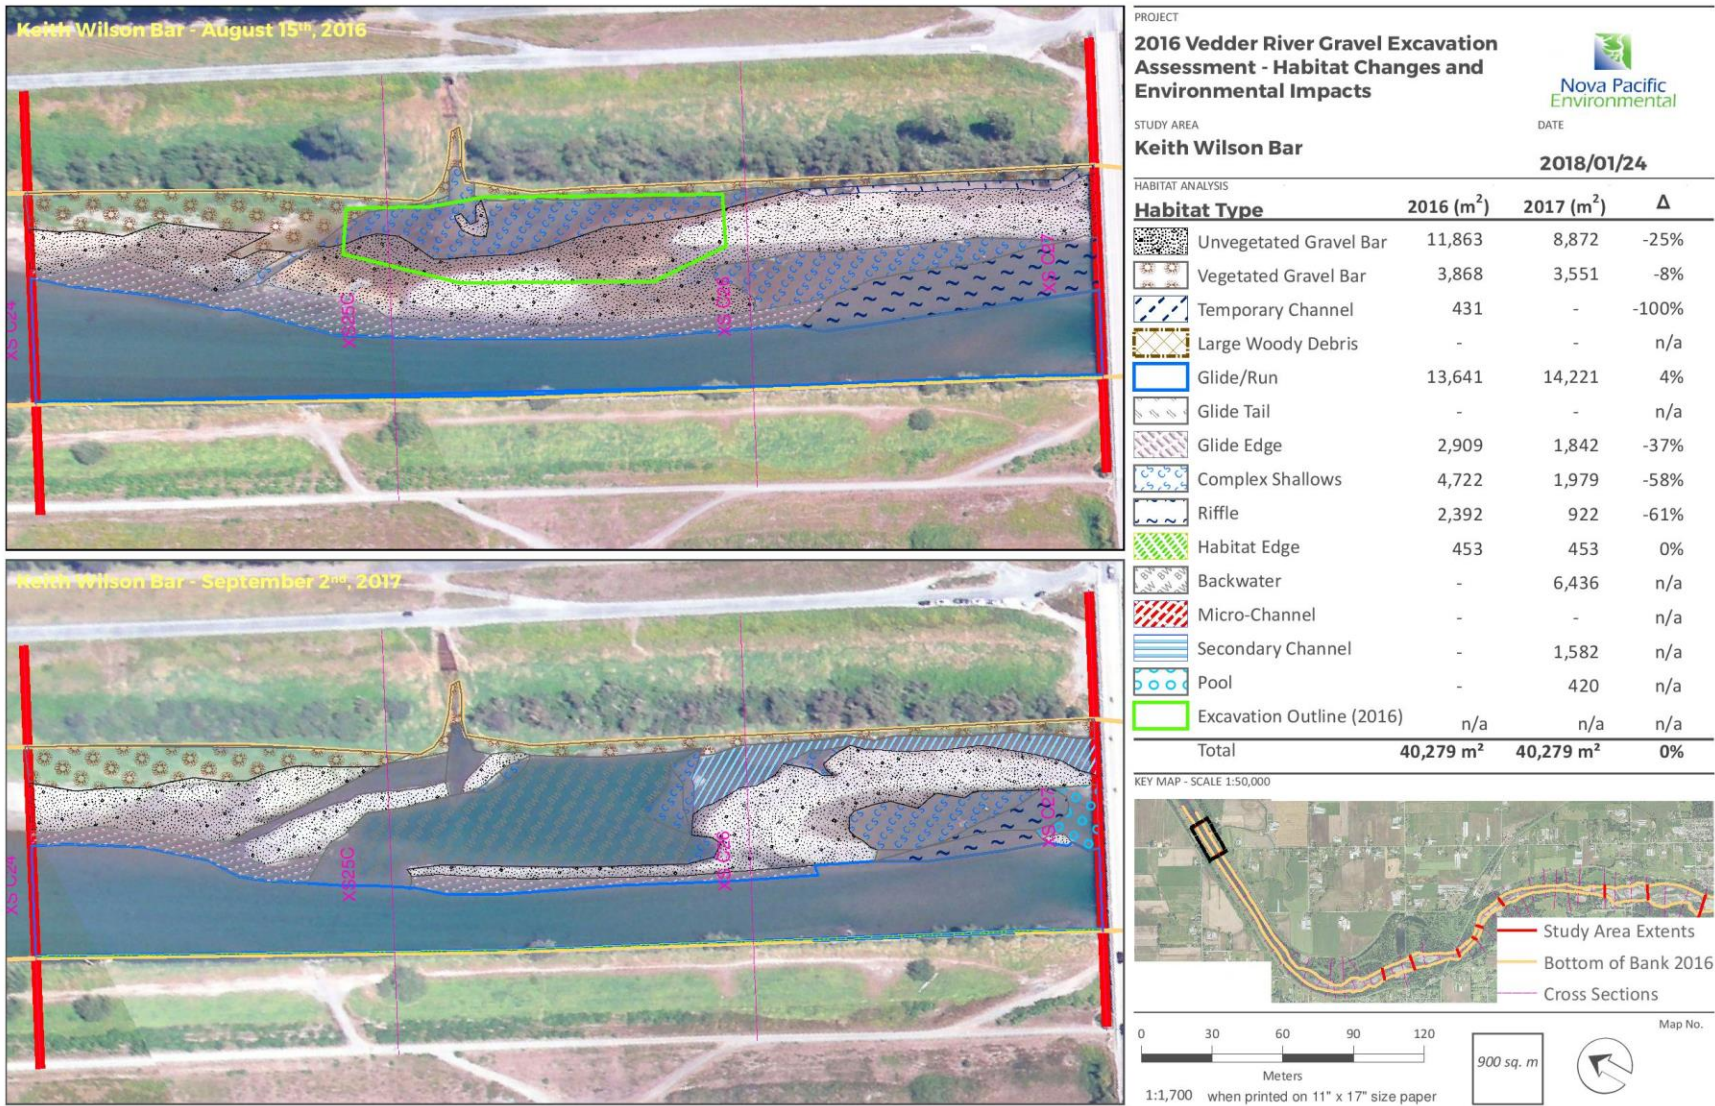
Figure 18: Habitat mapping of the Keith Wilson Bar location prior to excavation in 2016 (top) and one year later in 2017 (bottom).

The major habitat changes at Keith Wilson Bar include the addition of a large backwater habitat within the excavation area and addition of secondary channel habitat along the right bank upstream of the excavation. Most other mapped changes were upstream of the excavation and are likely associated with the structure of Keith Wilson Bridge rather than the excavation.

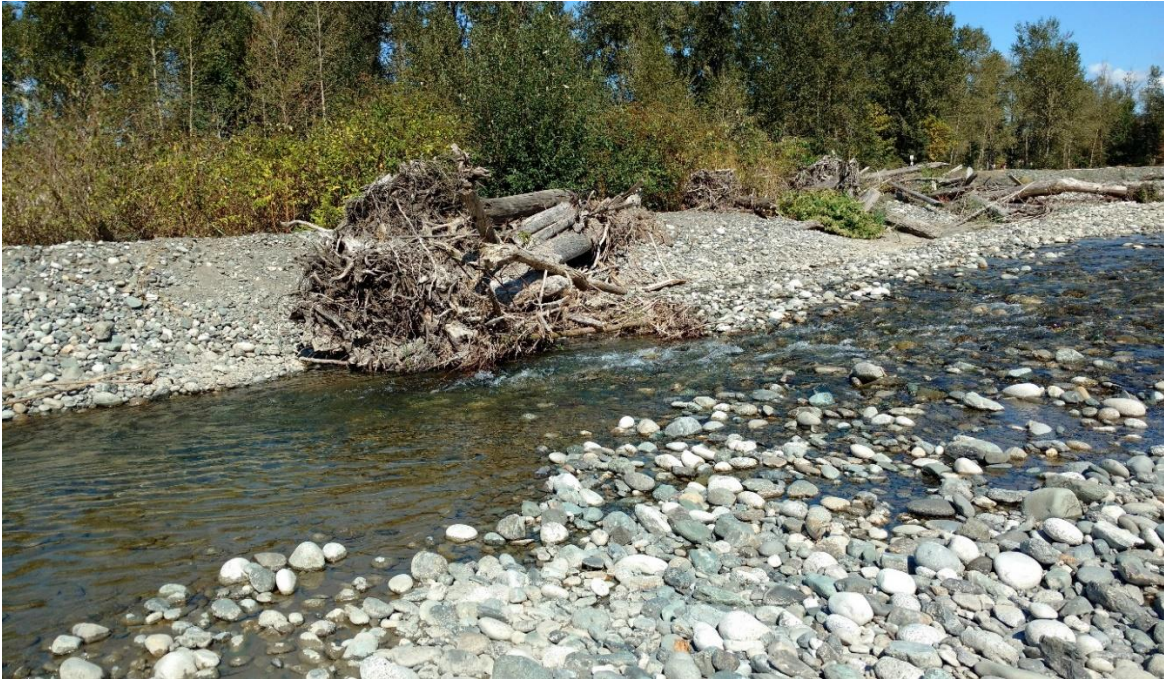
G1(a): LWD structure (LWD #G2016-1) placed in scalped pit along the channel-side in 2016 is still. The boulder platform constructed at this location may have contributed to riffle formation. Part of the river now flows through the scalped area. Picture taken on August 13, 2017.

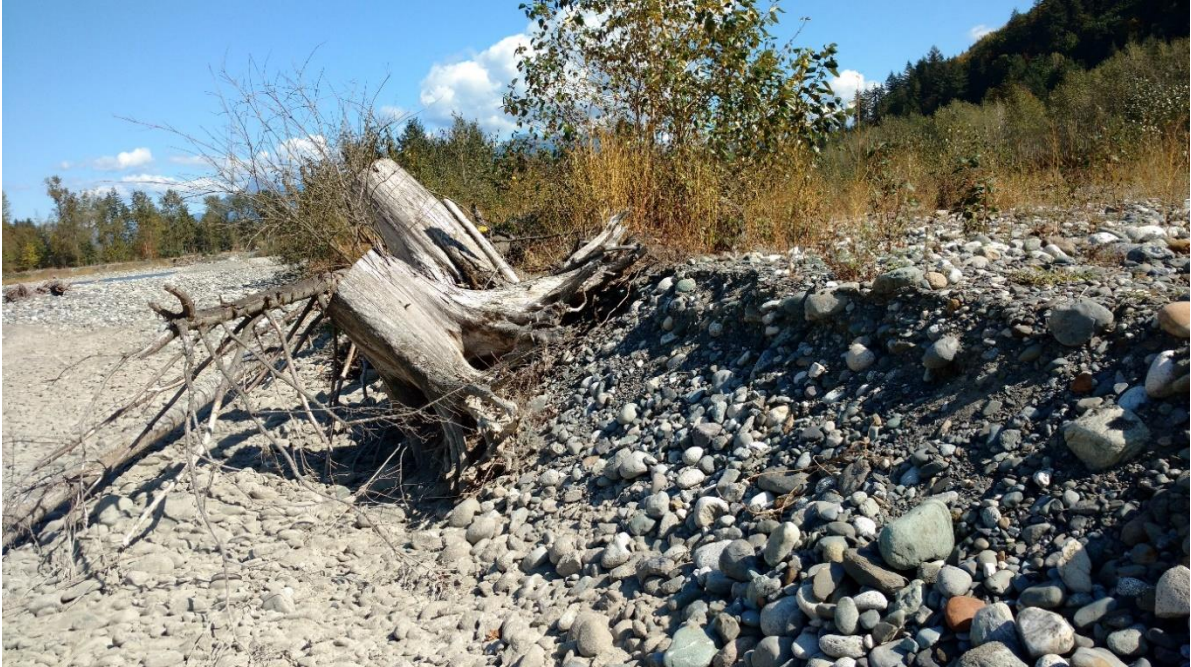
G2(a): LWD structure (LWD #G2016-2) placed in scalped pit along the bank-side is gone. Some other LWD have collected near the area. A platform of boulders created upstream of LWD complex to enhance fish habitat is covered with gravel. Picture taken on August 13, 2017.

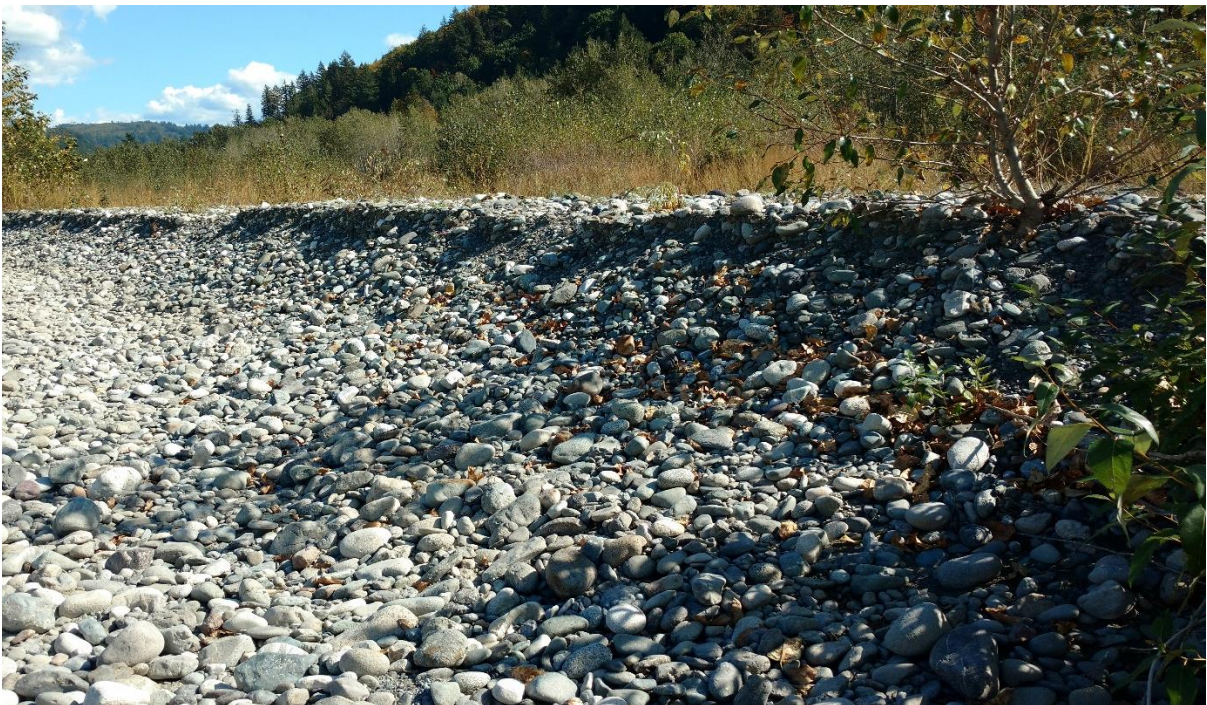
G3(a): LWD structure (LWD #G2016-3) placed in scalped pit along the bank-side is gone. A platform of boulders created downstream of LWD complex to enhance fish habitat is covered with gravel. Picture taken on August 13, 2017.

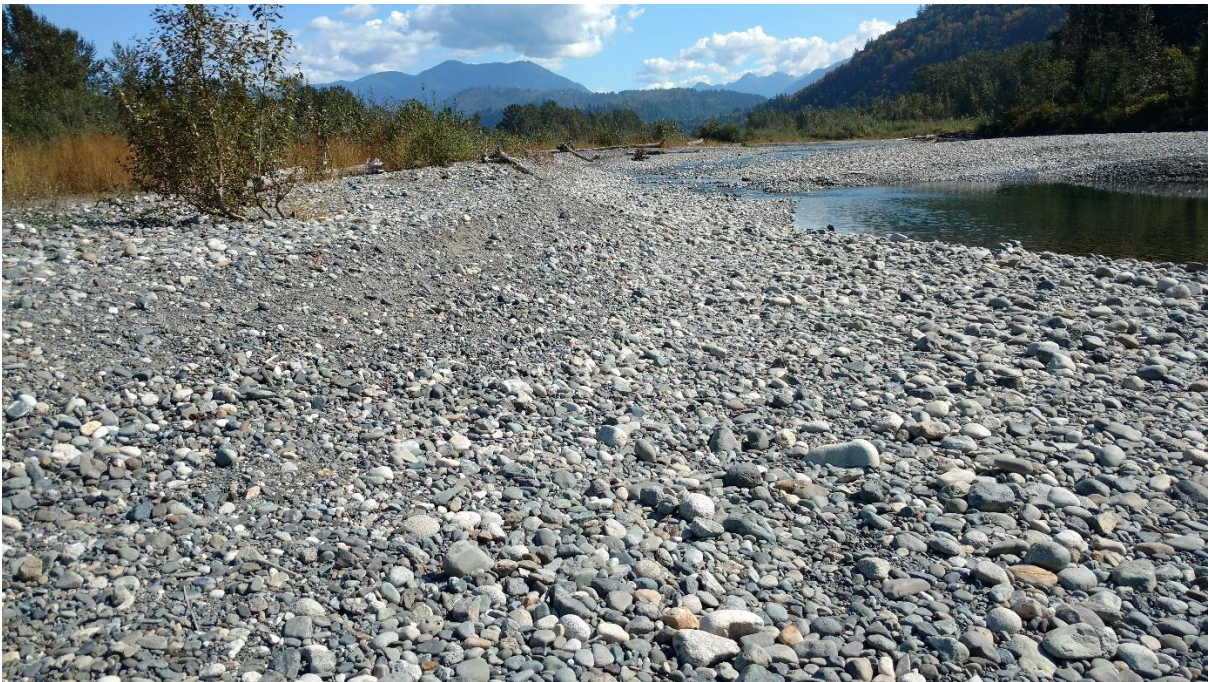
L1(a): LWD structure (LWD#L2016-1) placed along the bank-side of the pit in 2016 is gone. The excavated pit is mostly filled in. Picture taken on August 13, 2017.

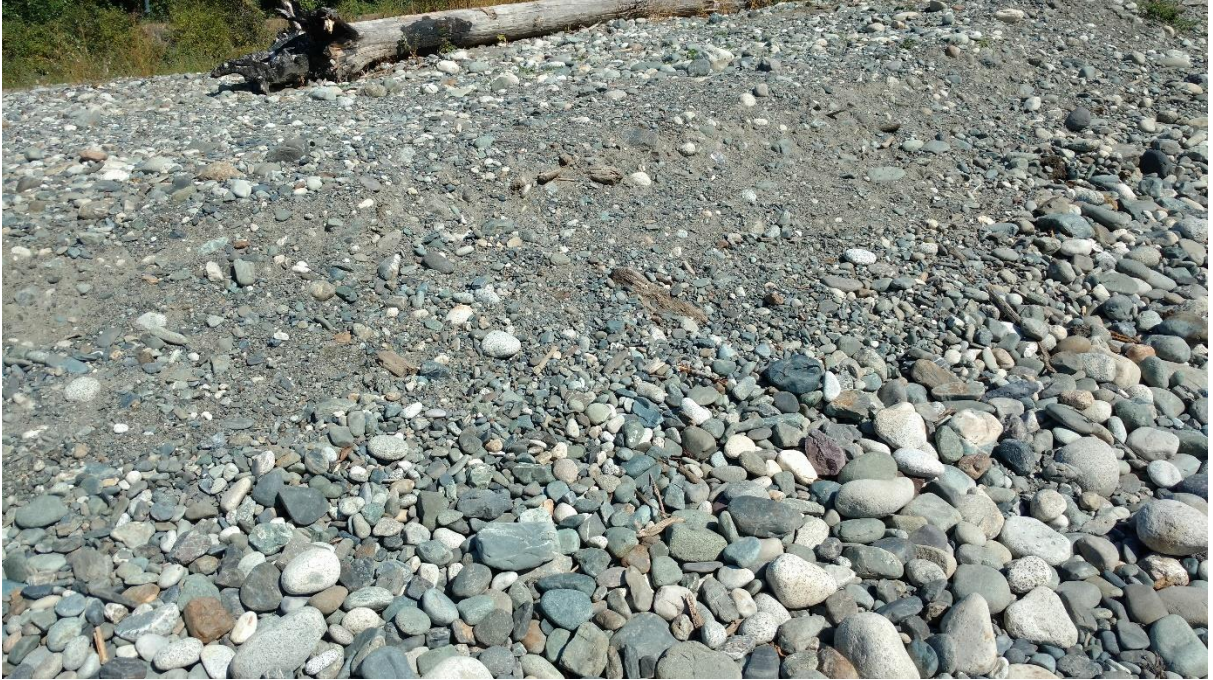
L2(a): LWD structure (LWD#L2016-2) placed along the bank-side of the pit upstream of LWD#L2016-1 in 2016 is gone. Picture taken on August 13, 2017.

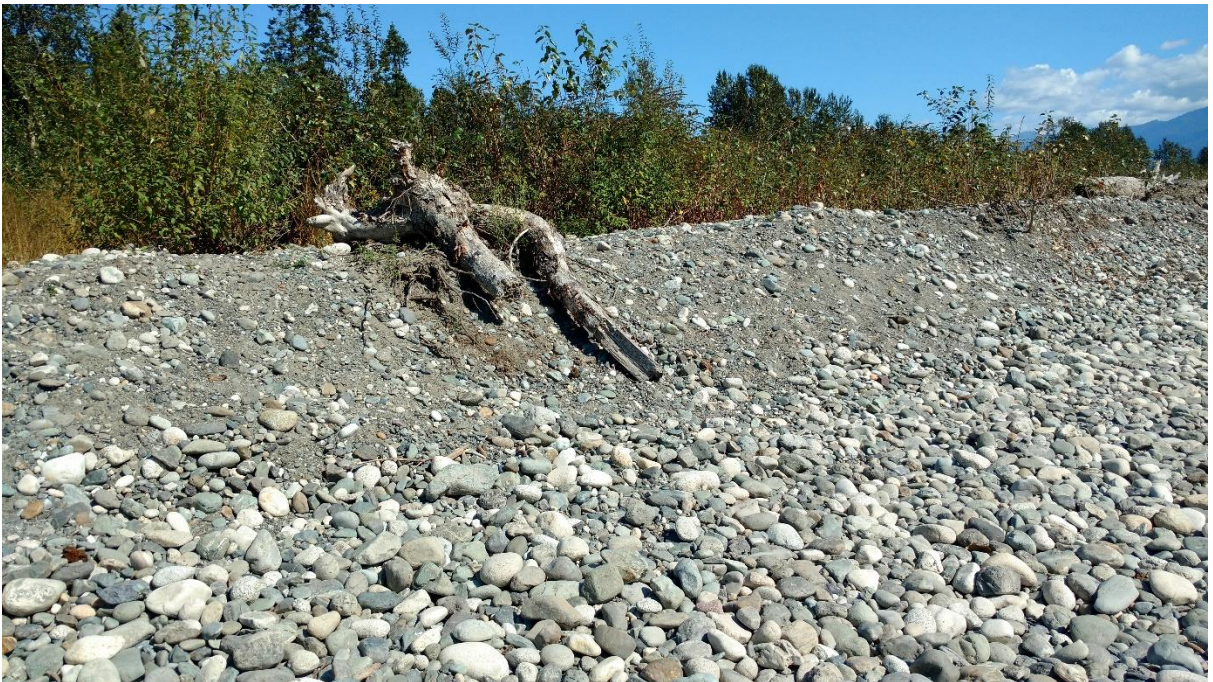
L3(a): LWD structure (LWD#L2016-3) placed along the bank-side of the pit upstream of LWD#L2016-2 in 2016 is gone. Some LWD are present on top of the bank. Picture taken on August 13, 2017.

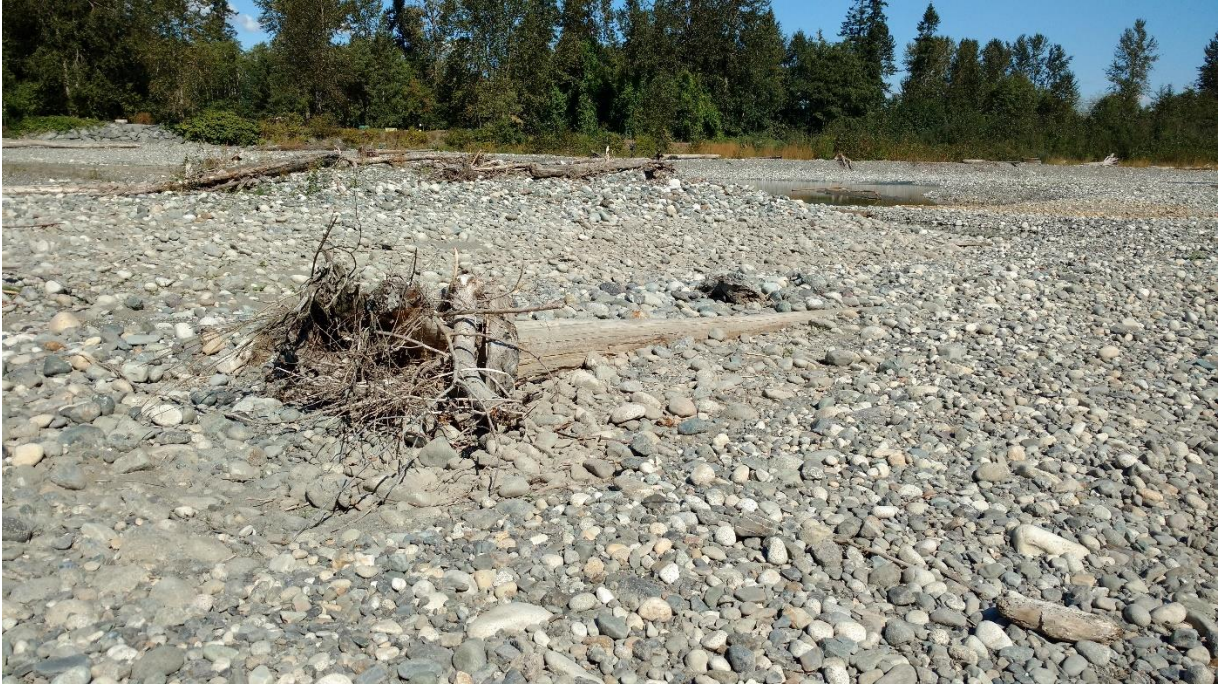
L4(a): LWD structure (LWD#L2016-4) placed in microchannel downstream of southwest outlet in 2016 is still in place. Microchannel was dry at the time of the assessment. Picture taken on August 13, 2017.

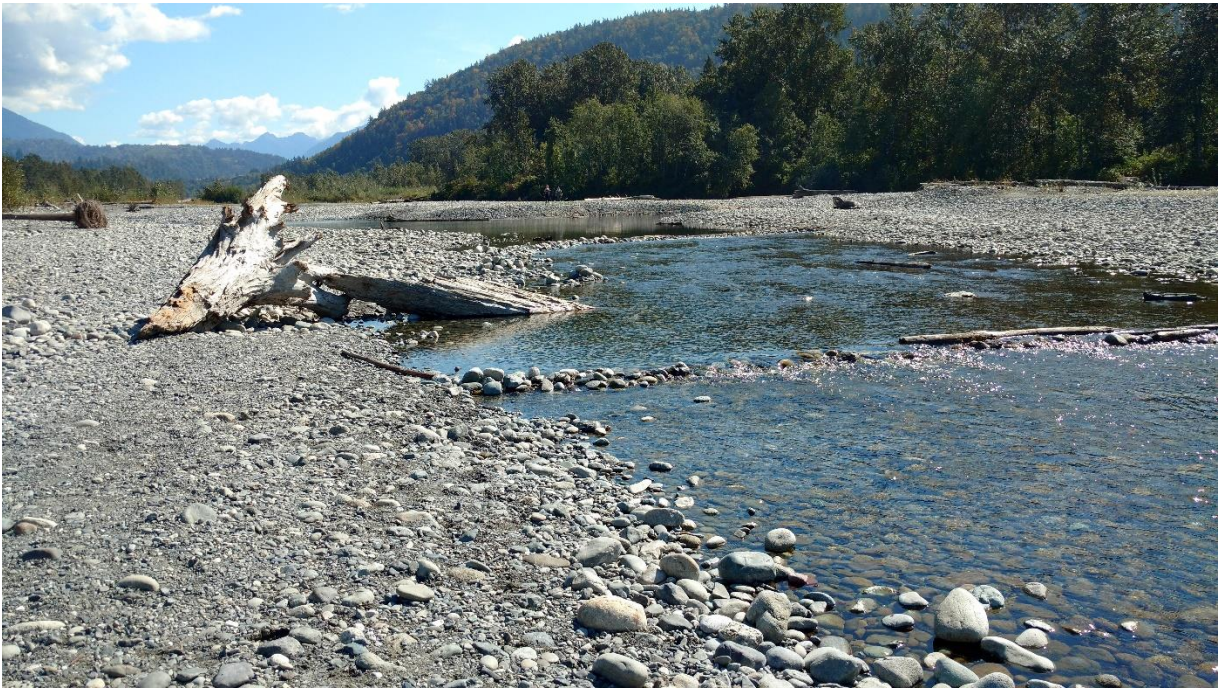
L5(a): LWD structures (LWD#L2016-5, LWD#L2016-6, and LWD#L2016-7) were placed along excavated habitat channel in 2016. Only LWD#L2016-7 is still in place. Channel attributes have improved as bed gravel has replaced previously sandy substrate. Picture taken on August 13, 2017.

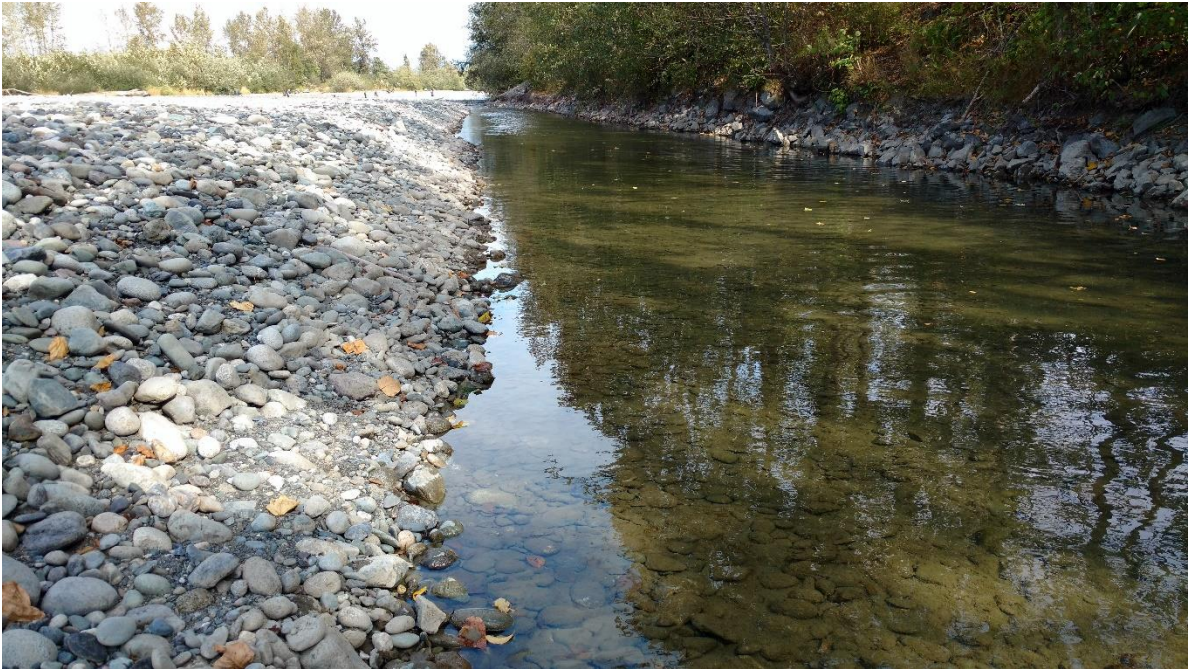
B1(a): LWD structures (LWD#B2016-1, LWD#B2016-2, and LWD#B2016-3) placed along left bank habitat channel in 2016 are gone. The habitat channel excavated along the left bank has retained both surface and groundwater flow, has supported spawning and offers a significant gain of rearing habitat. Picture taken on August 12, 2017.

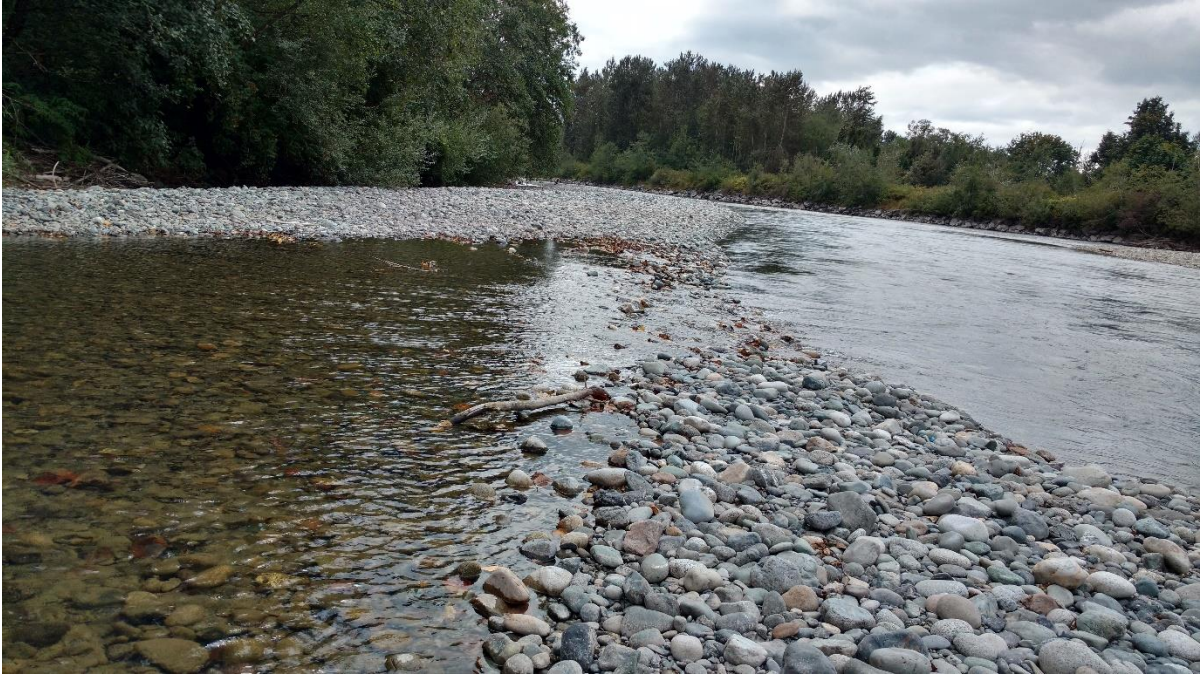
B3(a): Downstream the habitat channel connects to the main flow. Note that this section of the main channel is the former excavation footprint. With this flow diverted here the downstream portion of habitat channel (on the left in the distance of this photo) relies on sub-gravel flow for its continuing function. Picture taken on August 12, 2017.

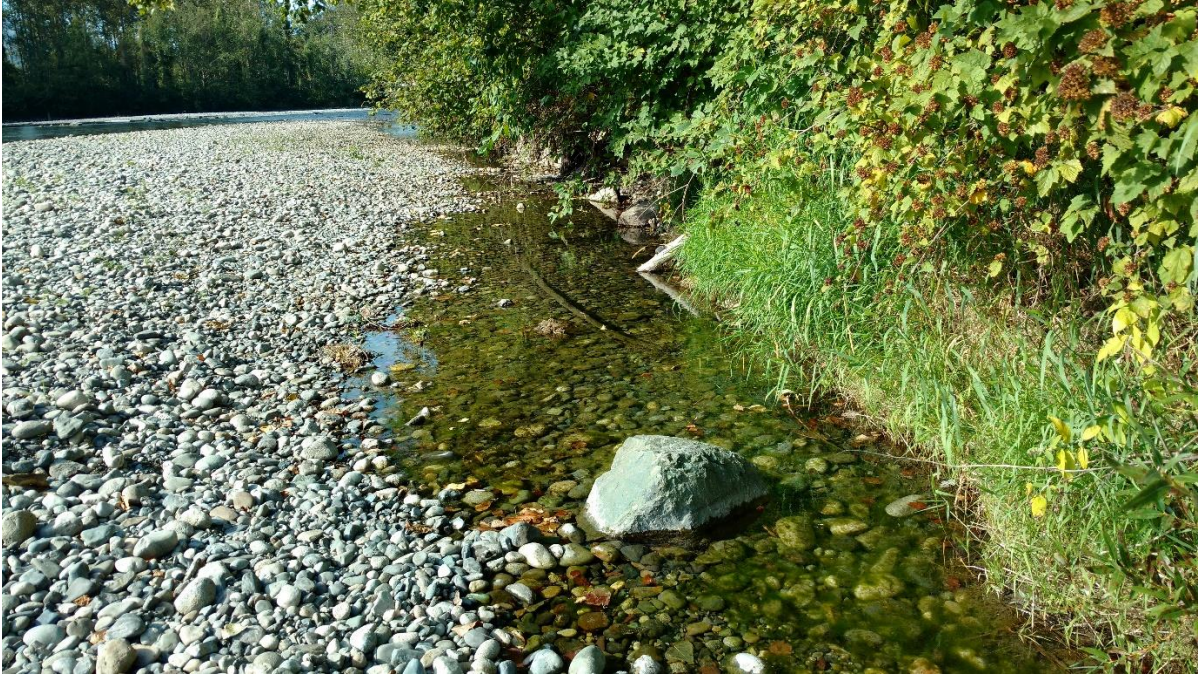
R1(a): Right-bank microchannel is groundwater-fed and remains connected to the main channel at downstream end. Picture taken on August 13, 2017.

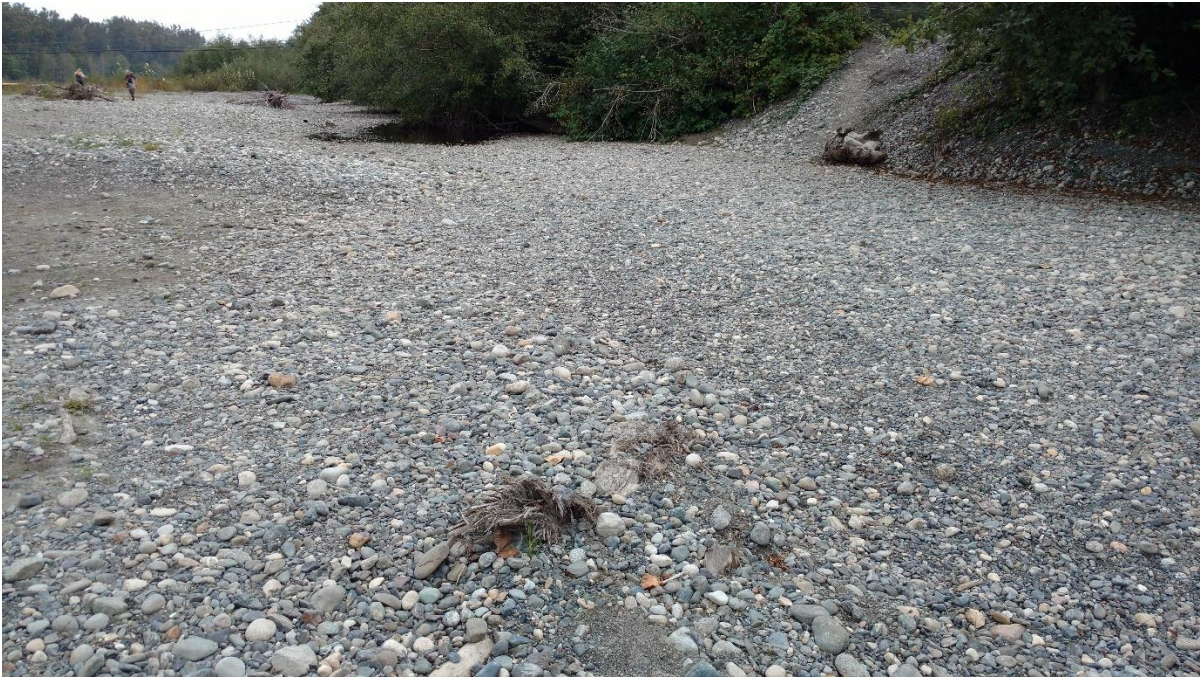
Y3(a): LWD structure (LWD# Y2016-3) placed along left-bank channel downstream of access ramp in 2016 has infilled and this part of the channel was dry at the current low flow conditions. Picture taken on August 12, 2017.
