2016 Vedder River Gravel Excavation
-
Habitat Changes and Environmental Impacts

(Revised) January 2018

Vedder River Management Area Committee

Nova Pacific
Environmental

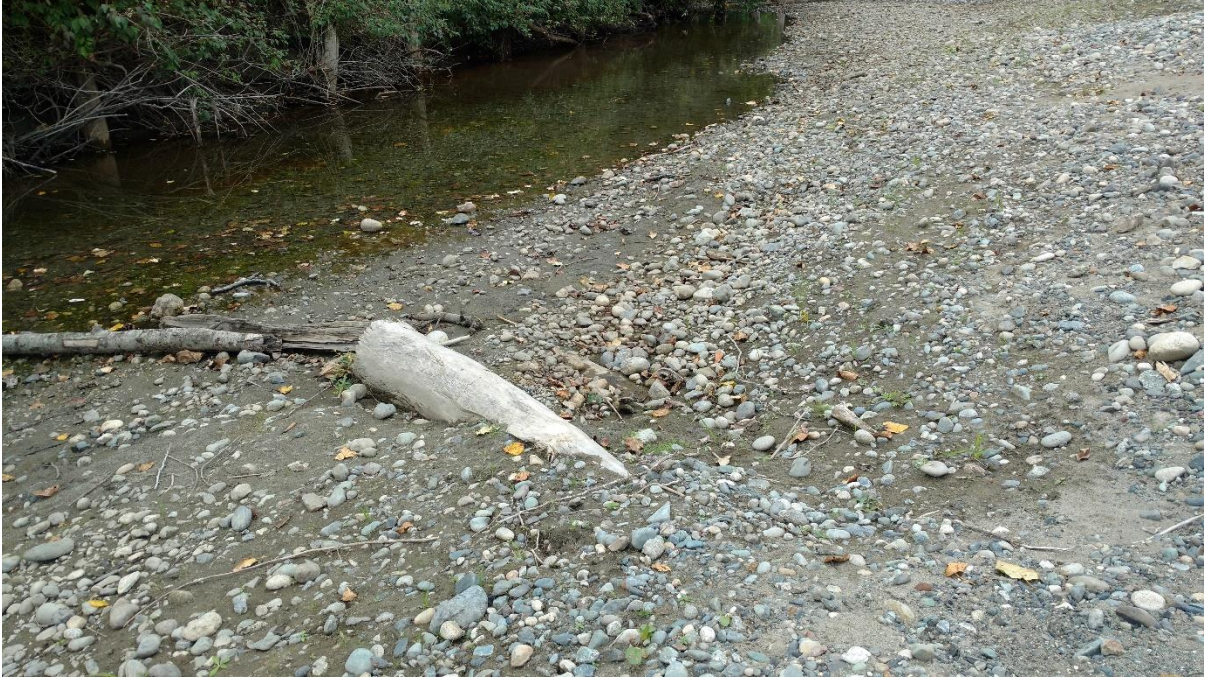
Y5(a): LWD structure (LWD# Y2016-5) placed along left-bank channel downstream of LWD# Y2016-4 in 2016 is still in place but some pieces of the structure are gone. Picture taken on August 12, 2017.

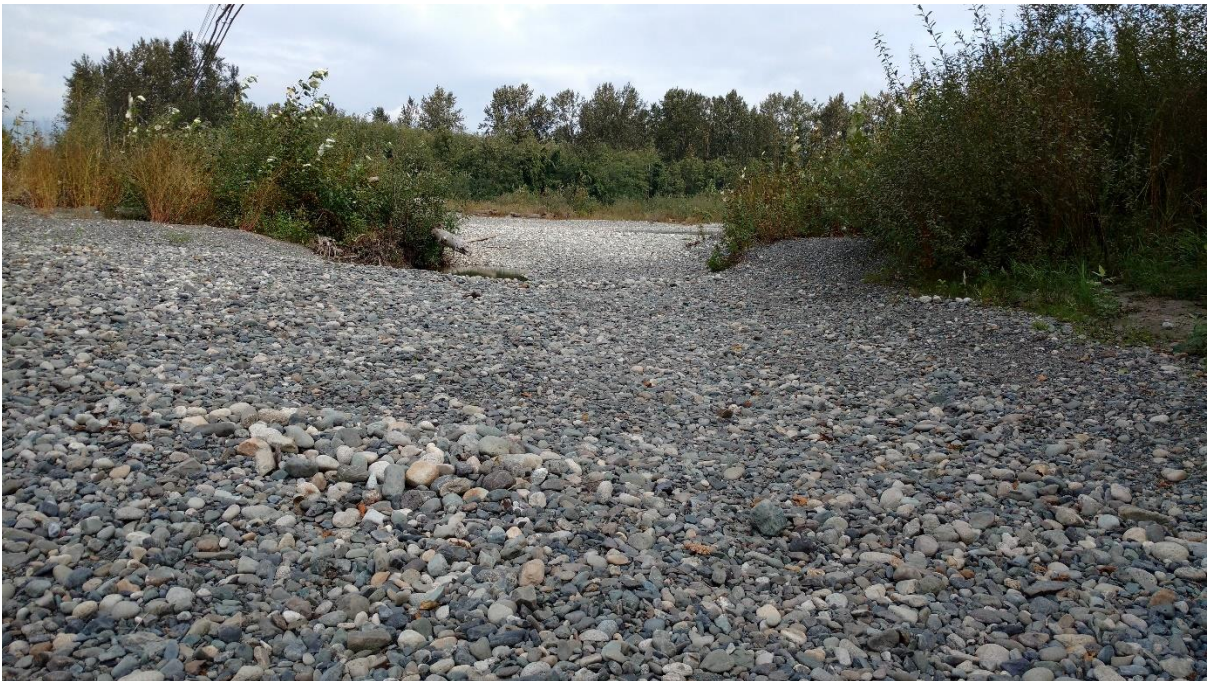
Y8(a): Habitat channel upstream of the site has partially filled and is dry. Picture taken on August 12, 2017 looking toward the river.

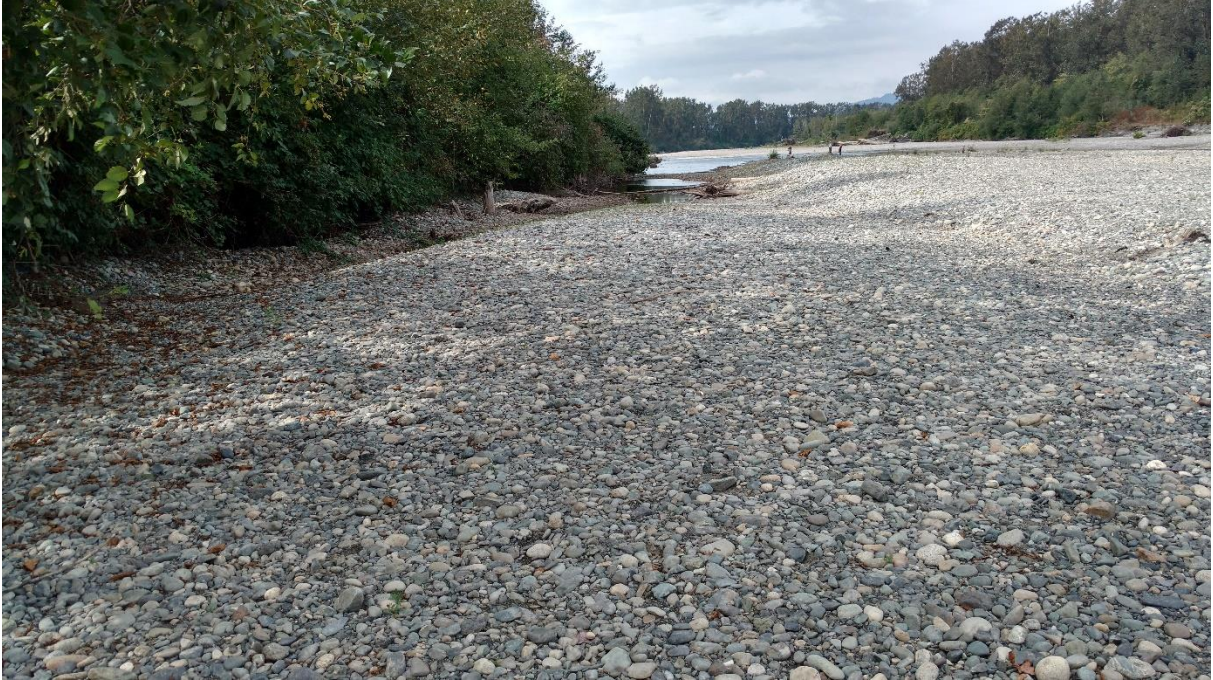
Y9(a): Habitat excavation downstream shows some infilling but still has sub-gravel flow downstream and remains connected to the main channel at the downstream end. Picture taken on August 12, 2017.
