Nova Pacific
Environmental

Proposed 2016 Vedder River Sediment Removal Project

May, 2016

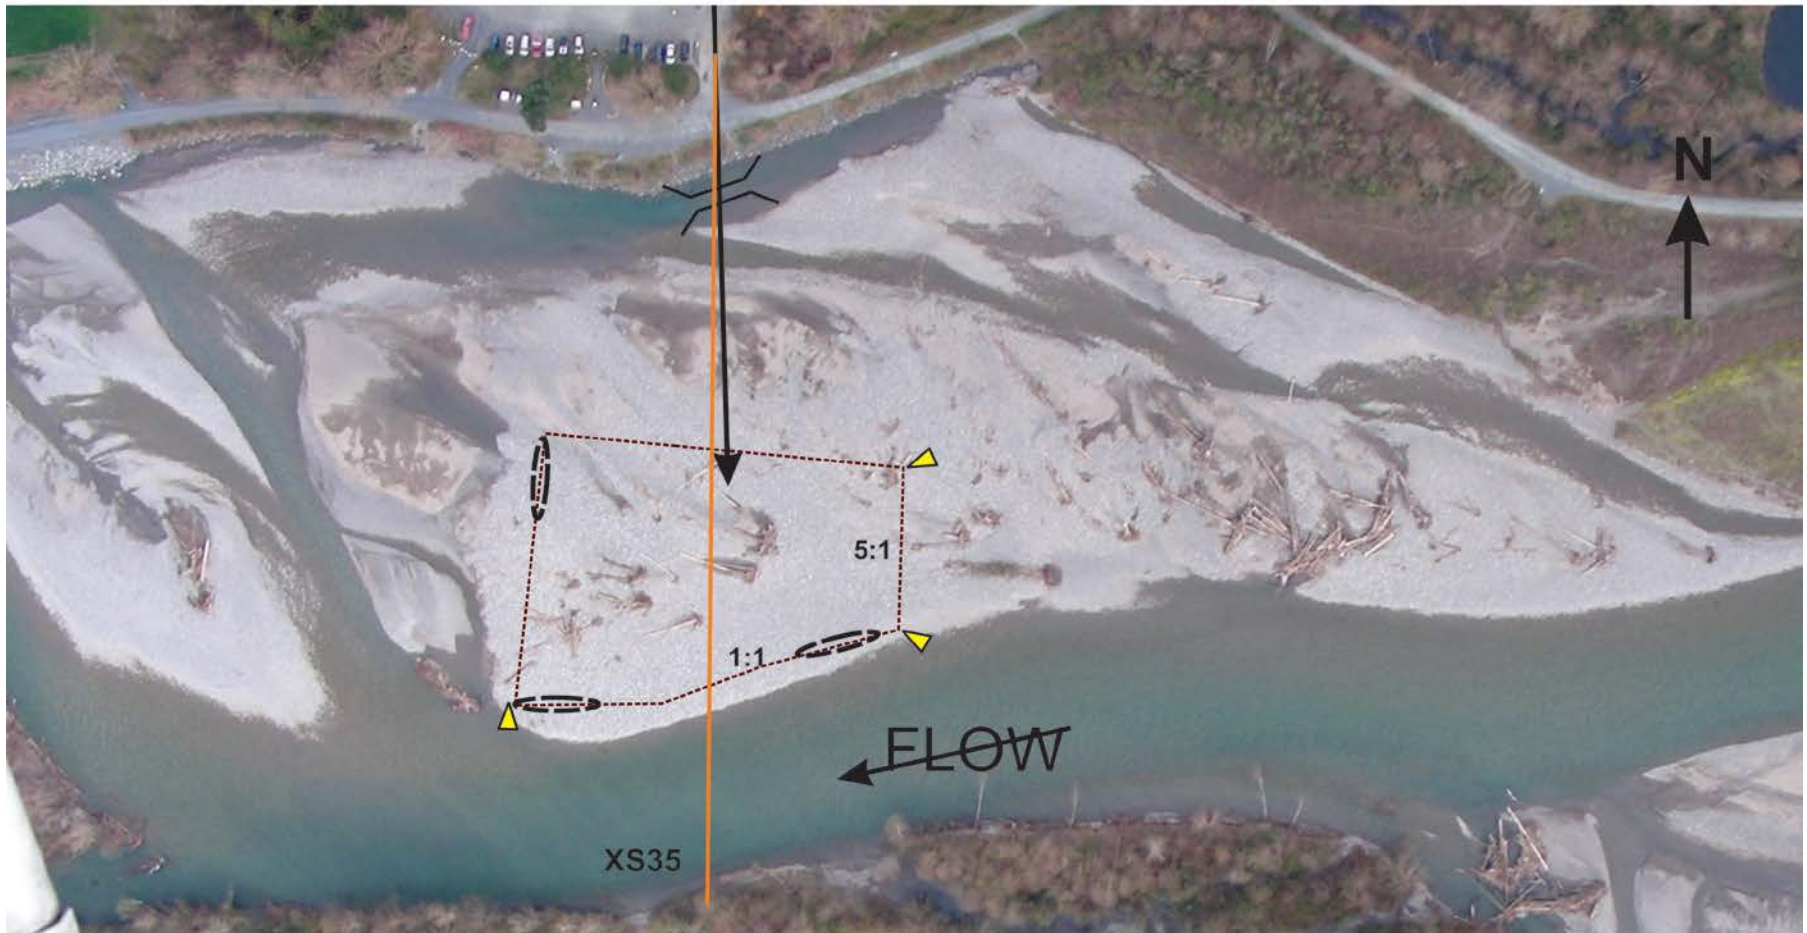
2016 Proposed Excavations: Lickman Bar (16-35M)

Second Draft Plan: April 12, 2016 Photo: March 19, 2016

Access Route
- Pit Slopes are 1.5:1 unless otherwise shown

Volume = 21,500m³
 Avg. Length = 105m
 Width = 70m
 Depth = 3.5m

Abundant LWD on site that can be keyed in around the excavation site. Detailed site design will limit flow exiting through right temporary channel. Wide openings will be excavated to the main channel to prevent trapping of fish.

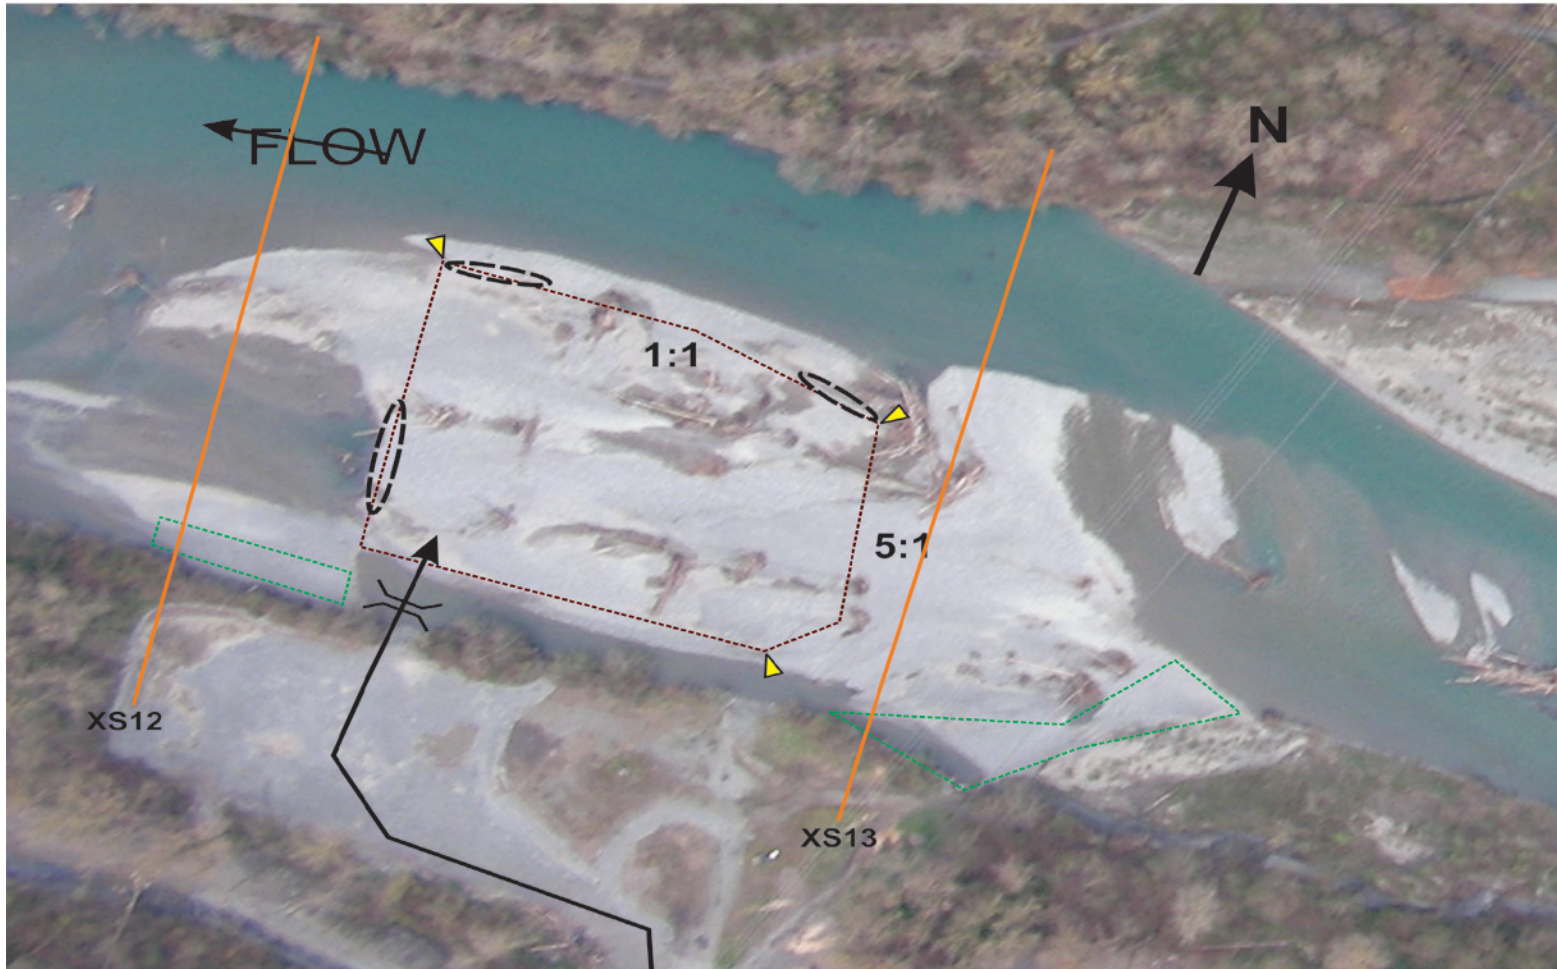
2016 Proposed Excavations: Yarrow Bar (16-13L)

Draft Plan: April 05, 2016 Photo: March 19, 2016

- Culvert Crossing
- Perimeter of proposed excavation
- Habitat excavation

- Slope change point
- Pit openings
- Access Route
- Pit Slopes are 1.5:1 unless otherwise shown

Volume = 14,300m³
 Avg. Length = 85m
 Width = 60m
 Depth = 3.0m
