2016 Vedder River Gravel Excavation
-
Habitat Changes and Environmental Impacts

(Revised) January 2018

Vedder River Management Area Committee

Nova Pacific
Environmental

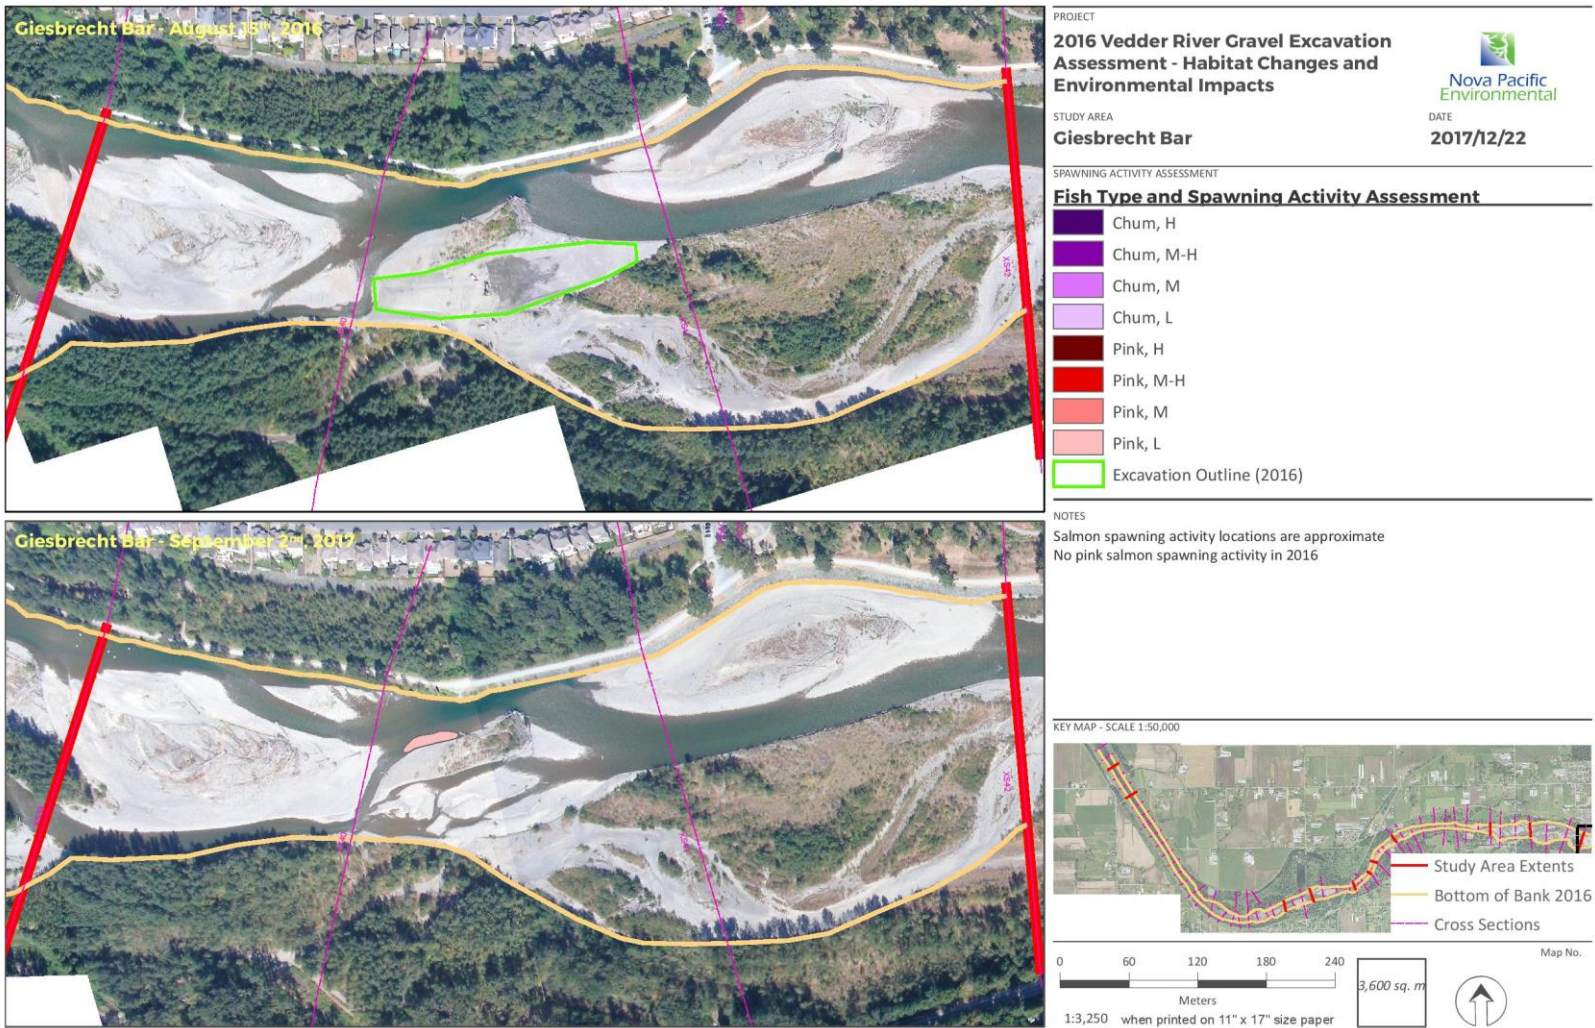
No redds or active spawning of chum salmon was observed at Giesbrecht Bar during the survey conducted in 2016. No carcasses were observed in this area either although active spawning was observed occurring at other bars and areas along the Vedder River at the same time as this survey.

Again, during the 2017 survey no redds, carcasses or active spawning of chum salmon was observed at Giesbrecht Bar although active spawning was observed occurring at other bars and areas along the Vedder River at the same time.

Pink salmon spawning (light) was observed in a small area along the outer, downstream edge of the excavated bar. Pink salmon on the Vedder River have been consistently observed to spawn in glide tail areas above riffles. The area where these spawners were observed is located within the only glide tail mapped in this study area.

Figure 4: Spawning distribution of Chum Salmon and Pink Salmon in the vicinity of Giesbrecht Bar in 2016 (top) and 2017 (bottom).

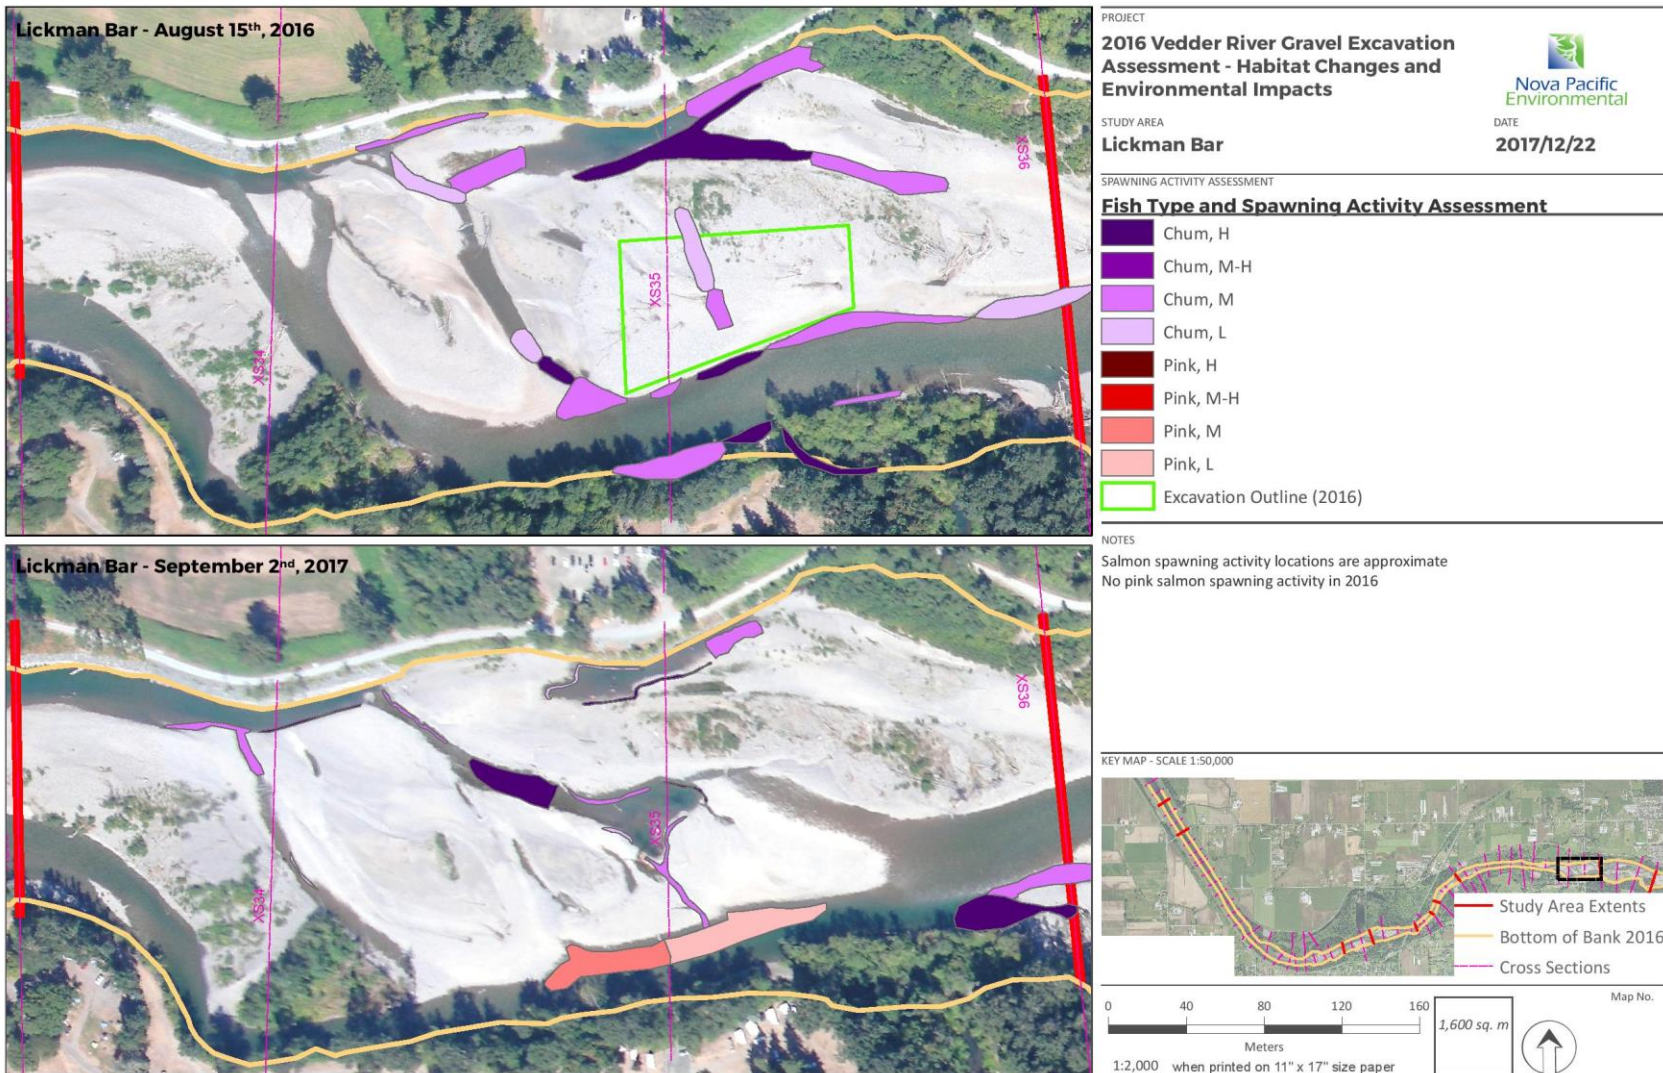
Heavy spawning of chum salmon was noted in the pool and complex shallows along the right bank below the public parking area and at the outlet of the microchannel on the left bank. Medium and light spawning was observed in the secondary channel downstream of the pool on the right bank and along both sides of the main channel between XS 36 and XS 35 and then into the secondary channel that crosses the main bar. The areas where chum spawning was occurring are influenced by perched water and sub-gravel flow.

Heavy spawning of chum salmon was noted in the complex shallows and pools again in 2017 including a large area just downstream of the pool within the excavation area. A mix of heavy and medium spawning was also observed in the pool and shallows complex along the right bank downstream of the microchannel. Medium spawning was seen along the small channel connecting the main channel to the pool in the excavation area and along other channels. The most intense spawning activity was noted in areas influenced by perched water and sub-gravel flow.

Pink salmon spawning was observed to be concentrated in the main channel along the excavation area and downstream which was a relatively shallow glide. This area is immediately downstream of where the gravel wedge has migrated to creating new glide tail, glide edge and riffle habitat within the study area.

Figure 7: Spawning distribution of Chum Salmon and Pink Salmon in the vicinity of Lickman Bar in 2016 (top) and 2017 (bottom).

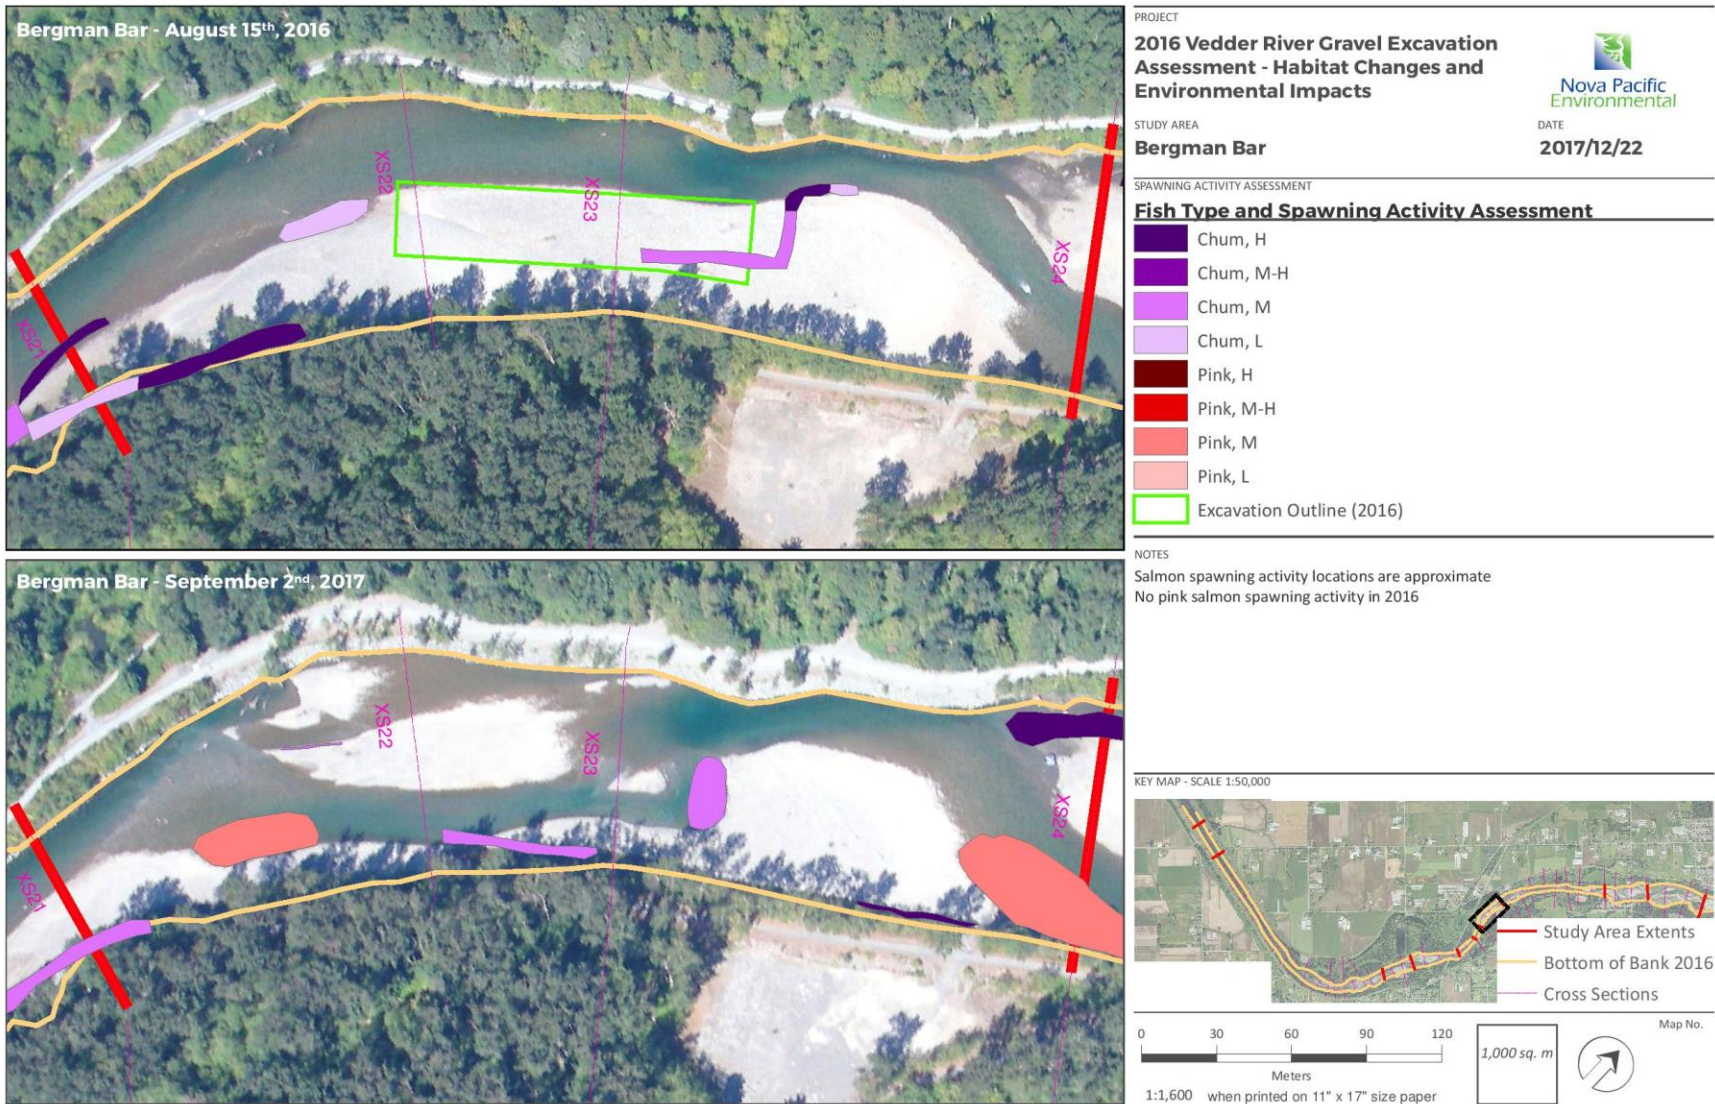
Pink salmon spawning was observed at the upstream end of the bar near cross-section 24 and along the downstream end of the left channel which passes through Bergman Bar. Both of these areas are associated with glide tail habitat.

Figure 10: Spawning distribution of Chum Salmon and Pink Salmon in the vicinity of Bergman Bar in 2016 (top) and 2017 (bottom).

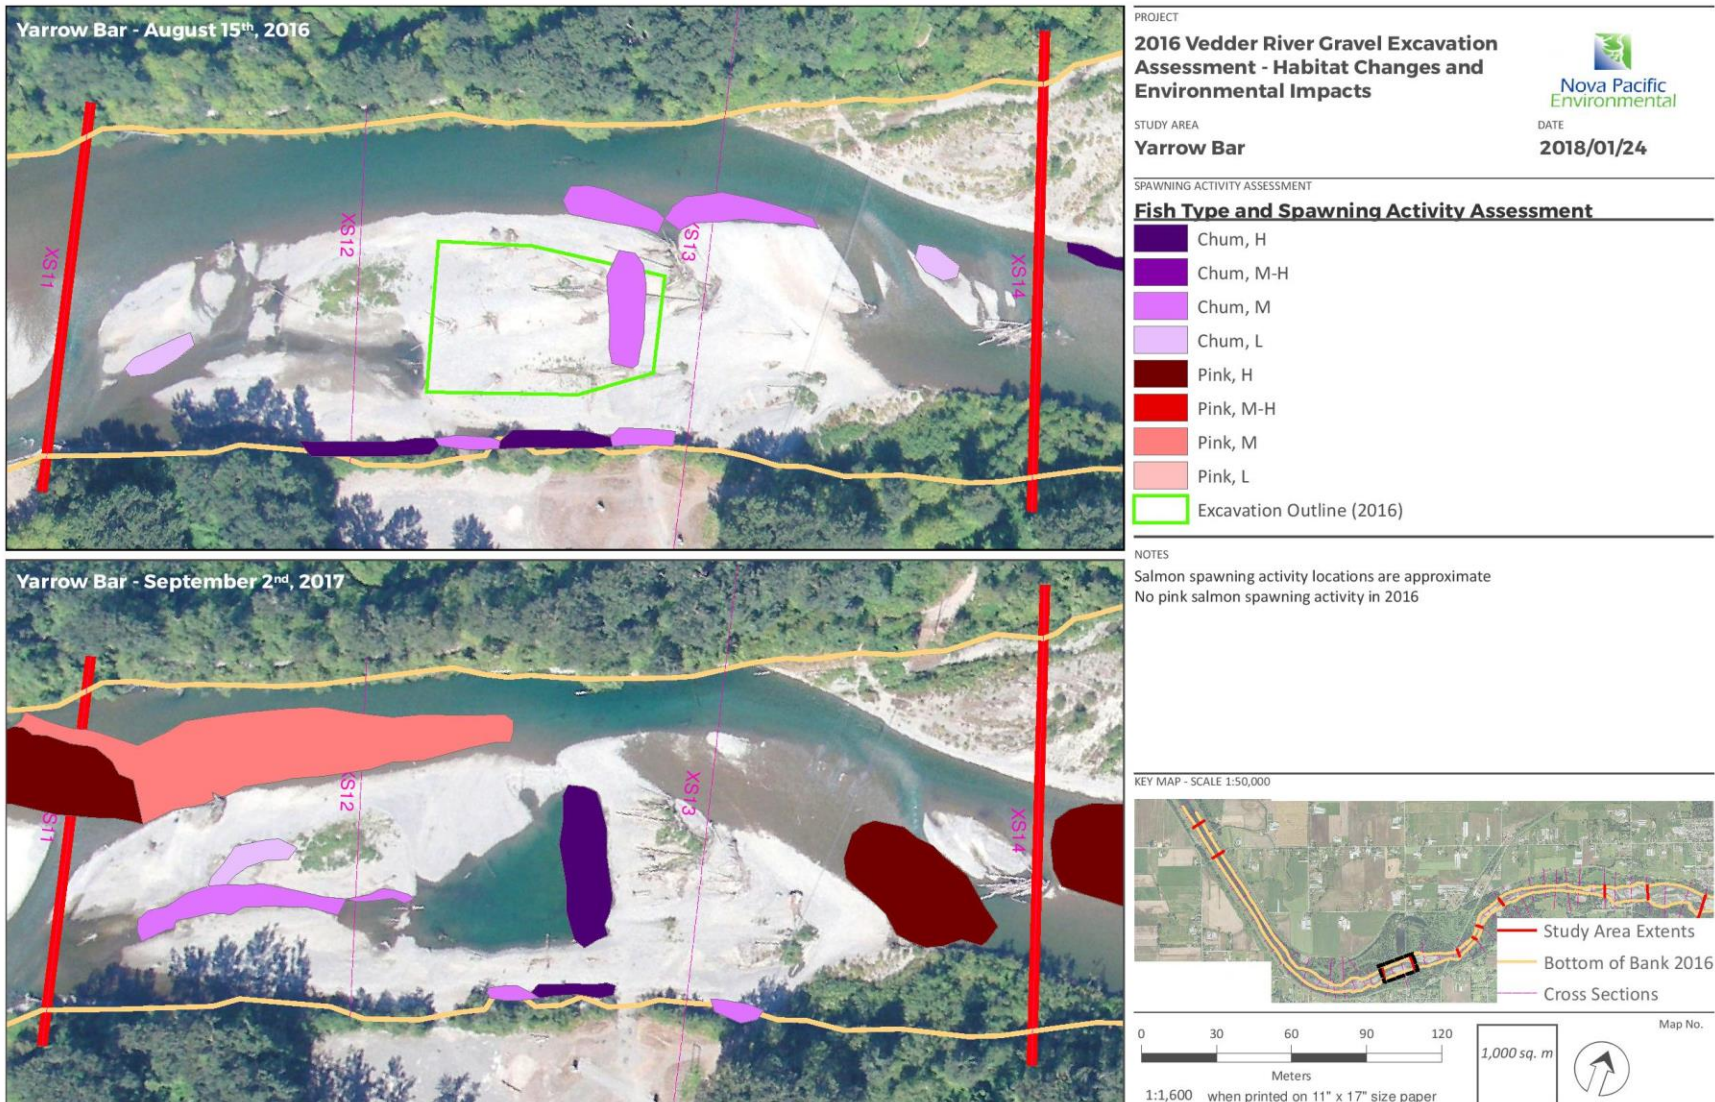
The 2016 Yarrow Bar excavation, as in 2014, has a persistent remnant of the excavation extending past the first fall freshet. While incomplete filling is not necessarily a concern the closure of the two openings along the thalweg creates risks to spawners. The habitat rating for this excavation while positive (7%) is offset by the risk of stranding and the isolation and incomplete filling of the pit. Accordingly, the overall assessment score is neutral (0).

Figure 16: Spawning distribution of Chum Salmon and Pink Salmon in the vicinity of Yarrow Bar in 2016 (top) and 2017 (bottom).

Two recommendations for the next excavation at this site are to ensure the berm left along the main channel is as narrow as possible and the openings are as deep and wide as possible and secondly to ensure the length to width ratio is at least approaching 2:1.

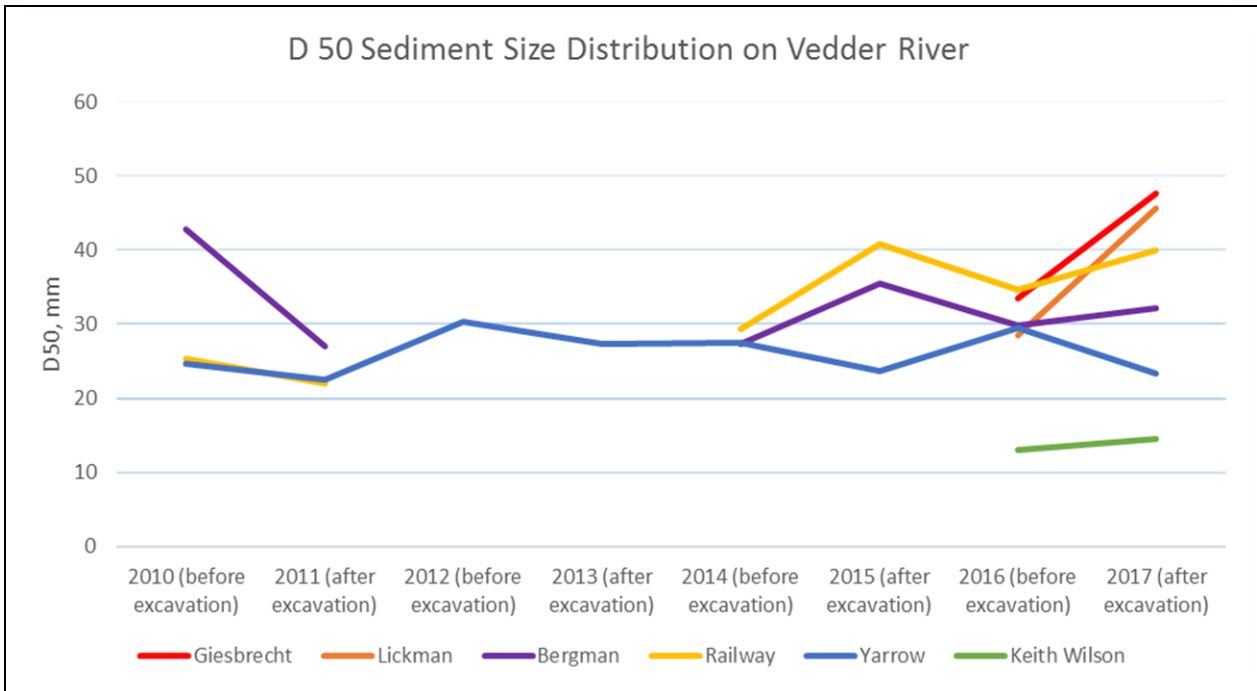
Due to flow events during the 2016/17 winter and 2017 spring, most of the gravel bars showed an increase in the average particle size between the 'before' and 'after' excavation data. In 2017 the average size of gravel at all bars increased after freshet except at Yarrow Bar. Bars further upstream (Giesbrecht and Lickman) showed the greatest increase in average particle size and Keith Wilson Bar showed the smallest increase in average particle size.

Figure 20: D50 sediment size distribution on Vedder River (2010, 2012, 2014, and 2016 excavations)

Over the eight years that sediment size has been recorded as part of this effort, only Yarrow Bar provides a continuous record of this analysis and thus can be used as a longer-term estimate of particle size deposition change. At Yarrow Bar the average gravel size has not fluctuated more than 10 mm over this period. The data from Railway Bar may indicate a trend to coarser sediments over time while other data could be explained by local geomorphic changes. Additional analysis of all data that includes sites not excavated in this cycle may provide evidence of longer-term change.

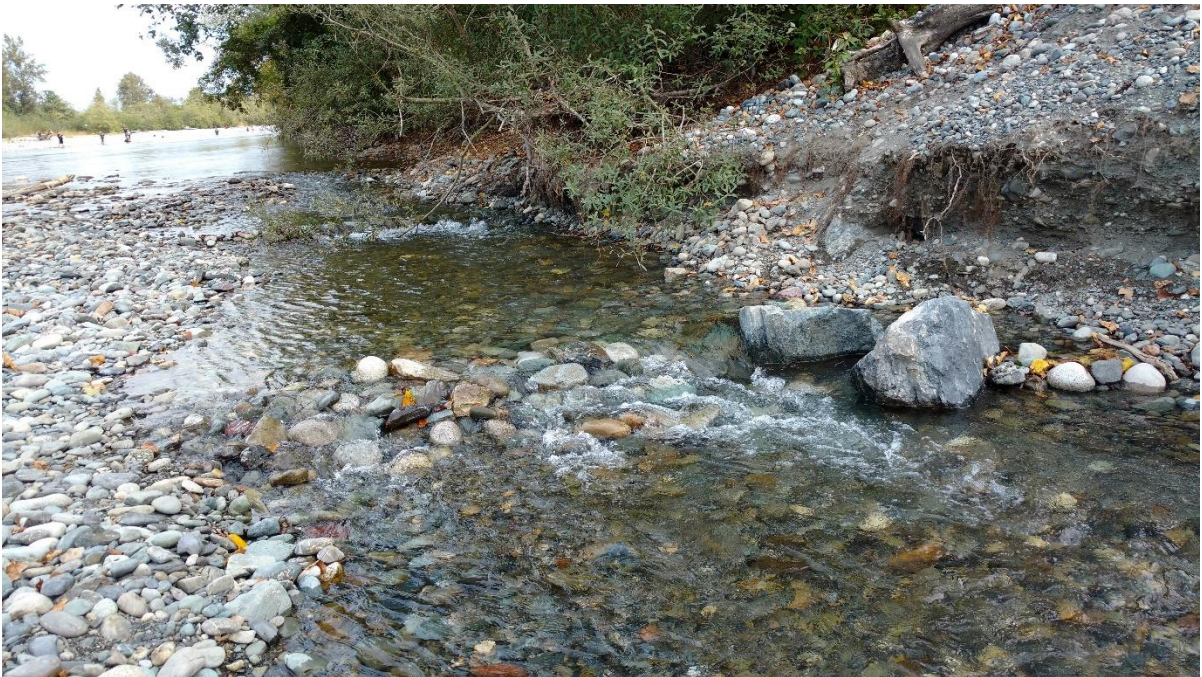
B2(a): The upstream connection of habitat channel to the main flow. Picture taken on August 12, 2017.

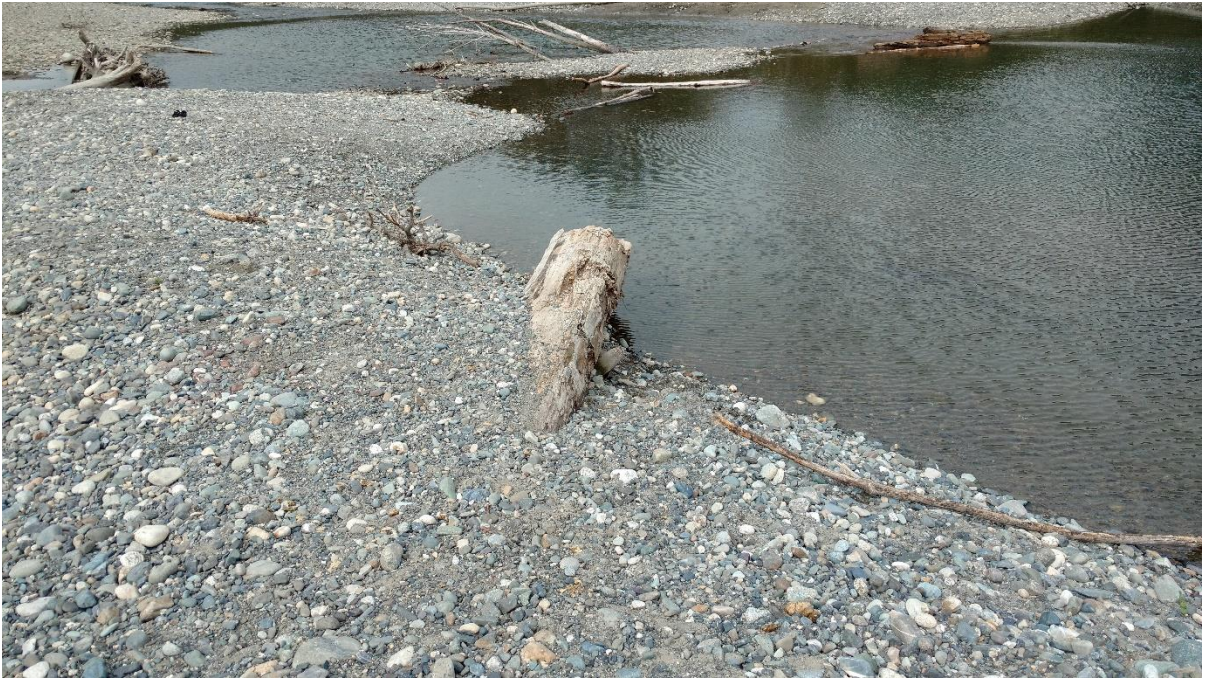
Y1(a): LWD structure (LWD# Y2016-1) placed along the bank side at downstream end of the pit in 2016 is still in place. Picture taken on August 12, 2017.

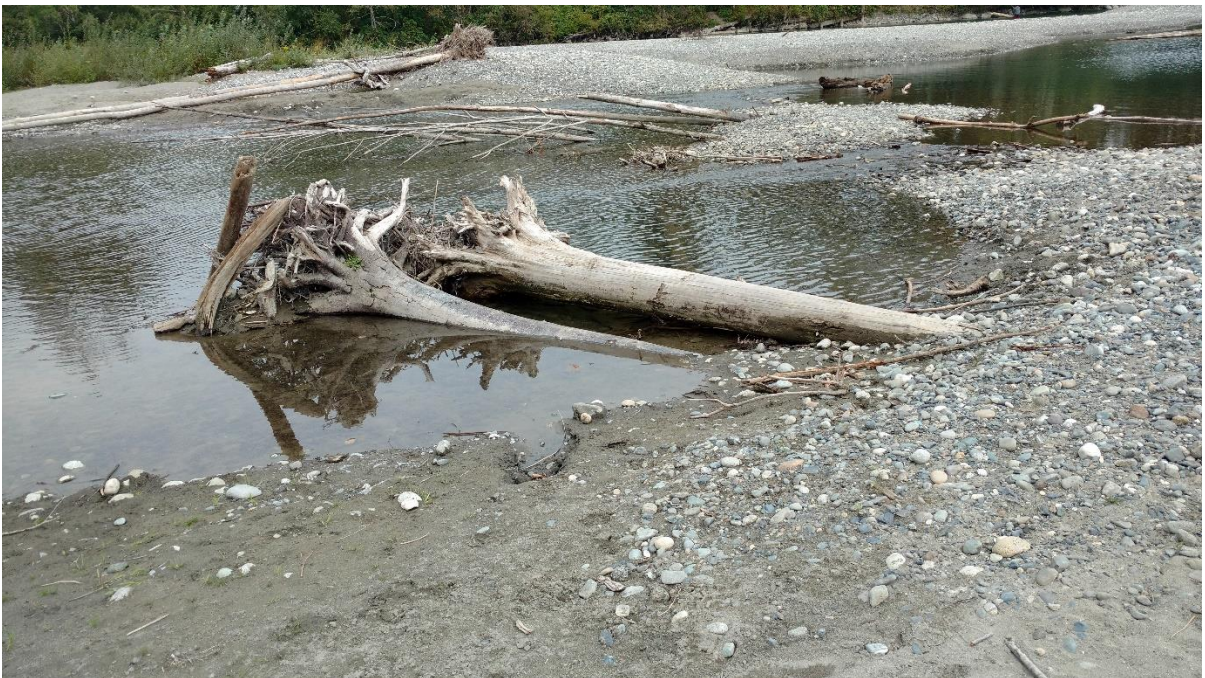
Y2(a): LWD structure (LWD# Y2016-2) placed downstream of the pit near the third opening in 2016 is still in place. Picture taken on August 12, 2017.

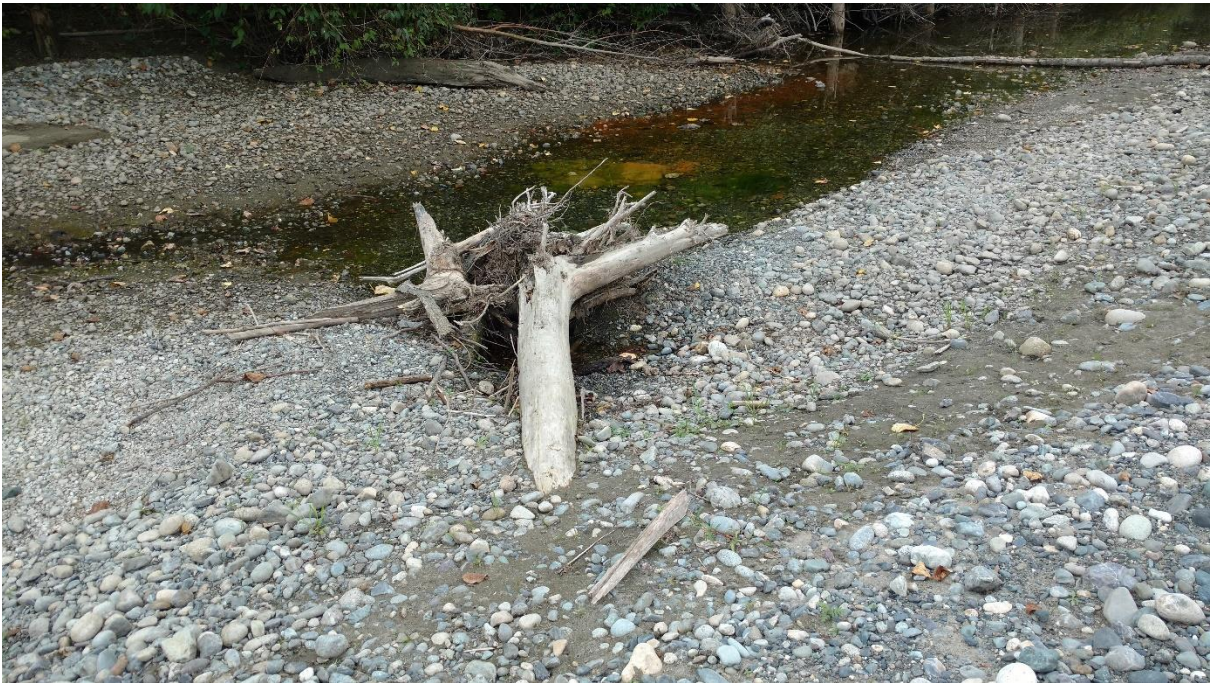
Y4(a): LWD structure (LWD# Y2016-4) placed along left-bank channel downstream of LWD# Y2016-3 in 2016 is in place. Picture taken on August 12, 2017.

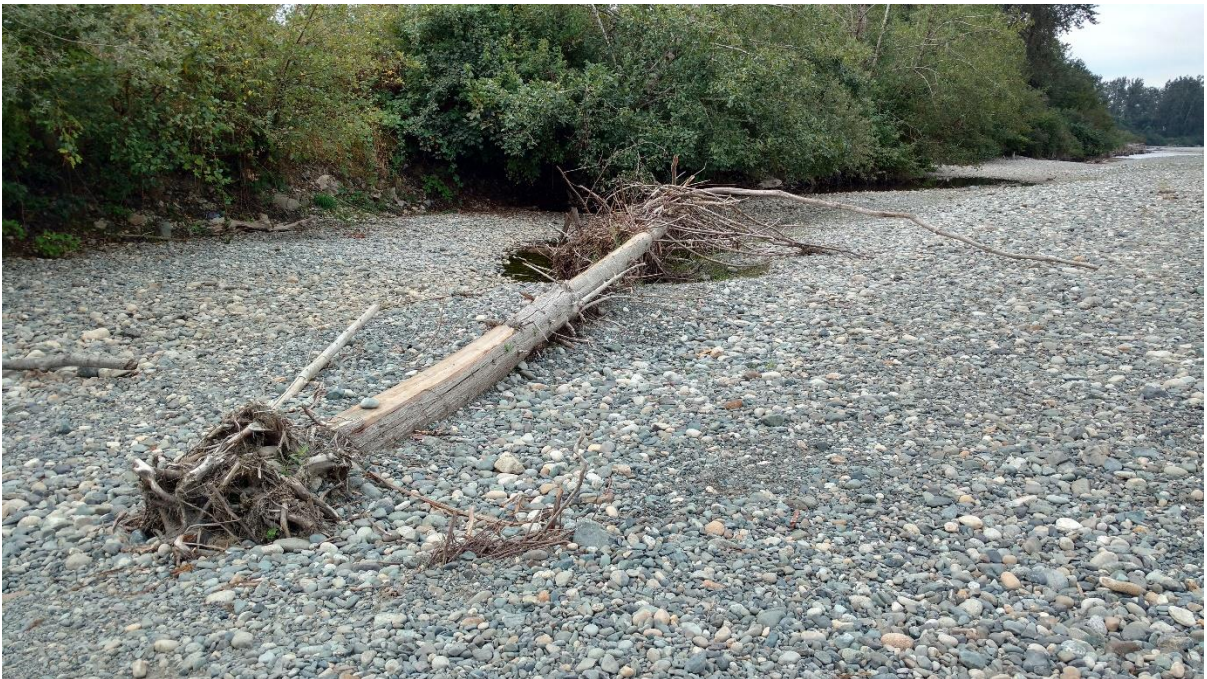
Y6(a): LWD structure (LWD# Y2016-6) placed along left-bank channel upstream of access ramp in 2016 is still in place. Picture taken on August 12, 2017.

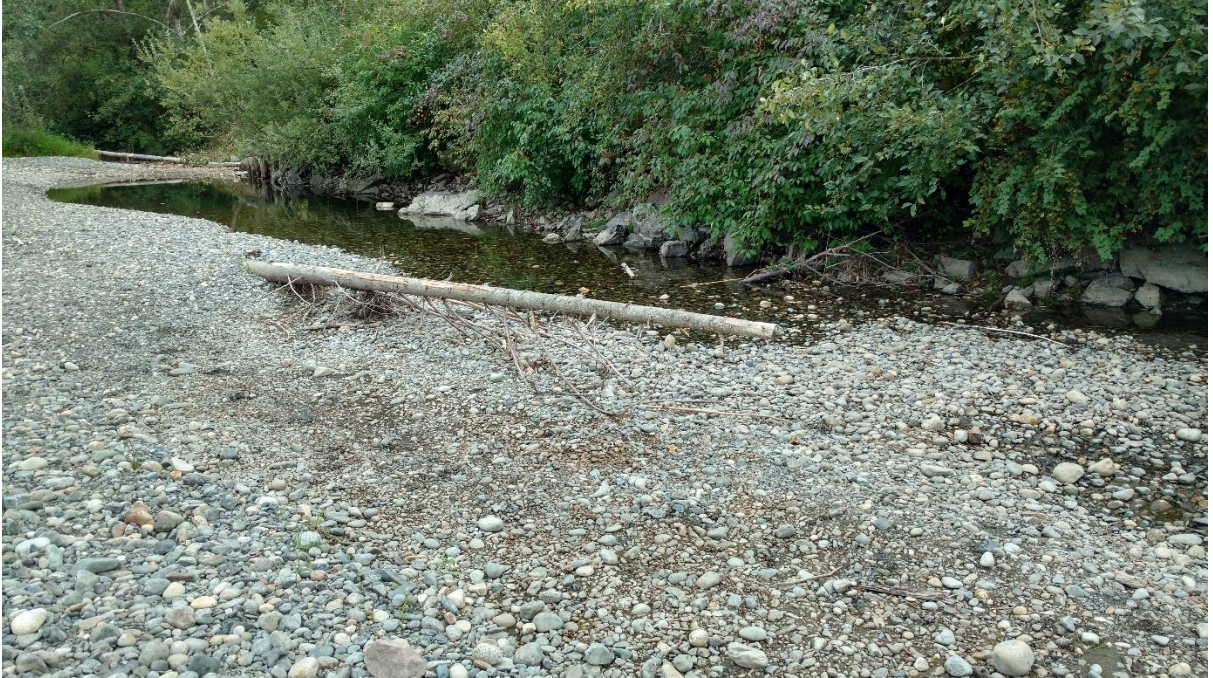
Y7(a): LWD structure (LWD# Y2016-7) placed along left-bank channel upstream of LWD# Y2016-6 in 2016 is still in place. Picture taken on August 12, 2017.

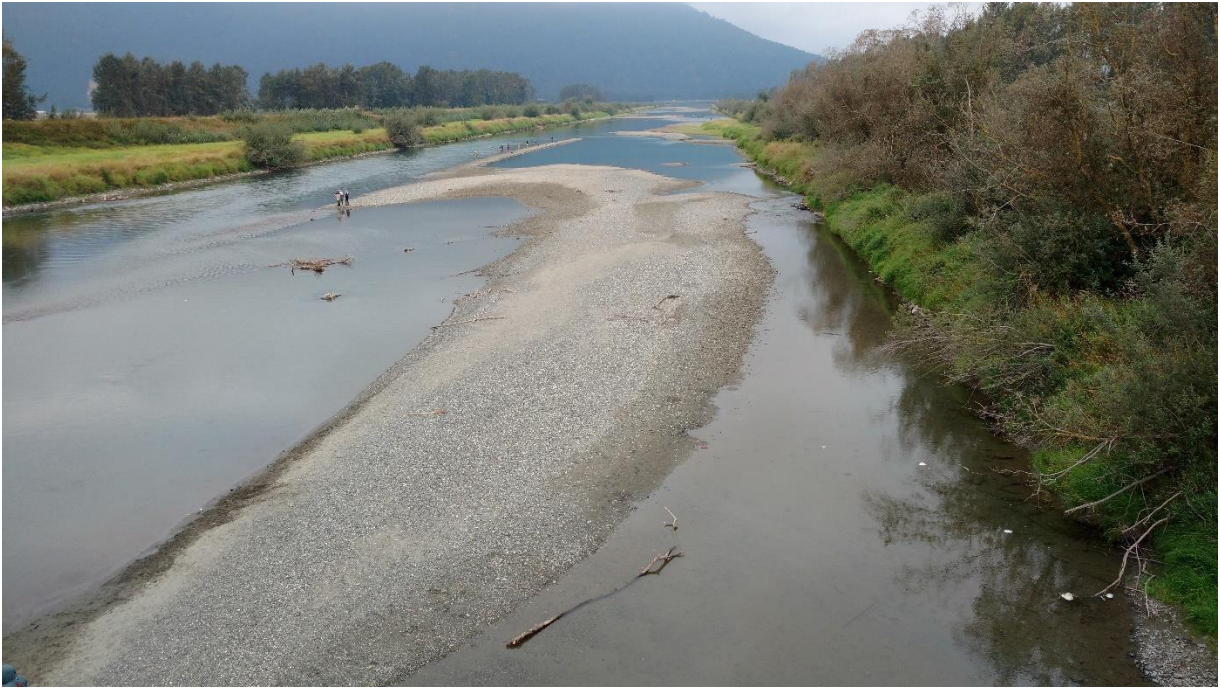
KW1(a): Excavated right-bank channel remains connected to the main flow, looking downstream from bridge. Picture taken on August 12, 2017.

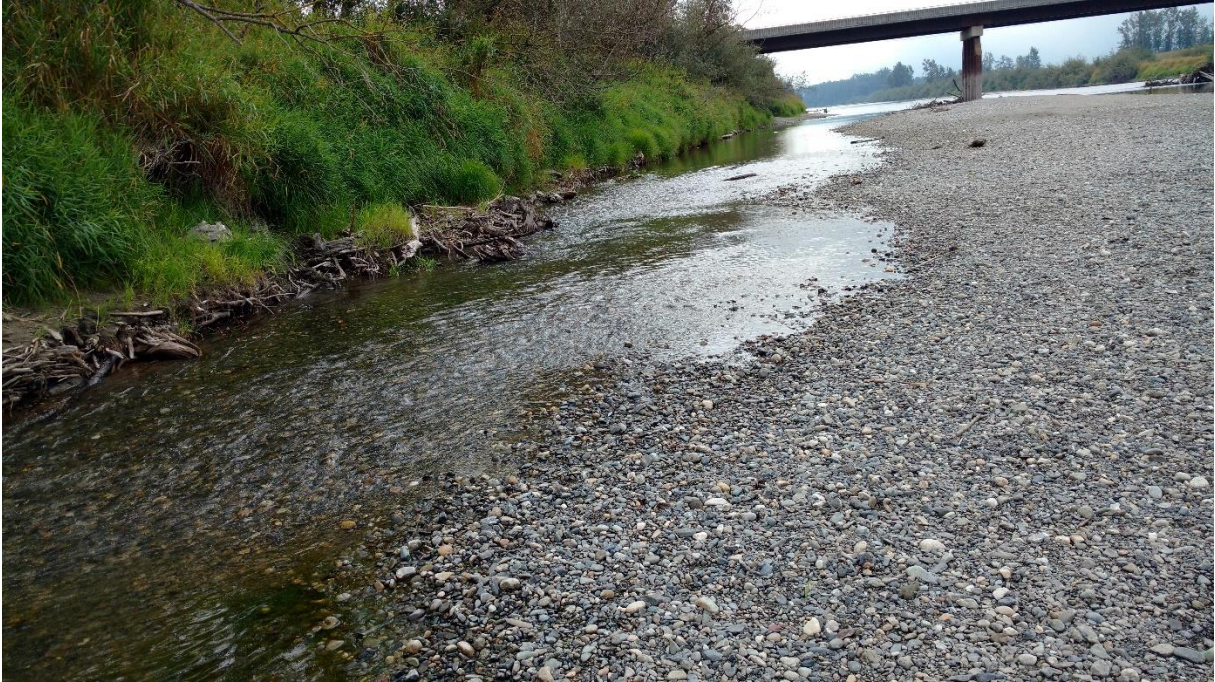
KW2(a): Upstream view of the right bank channel connected to the main flow. Picture taken on August 12, 2017
